Needs Tailored Interoperable Railway Infrastructure

Deliverable D2.6

Tailoring track to avoid corrugations: Traffic dependant selection of rail cross-section, clips and pads to avoid or delay corrugation

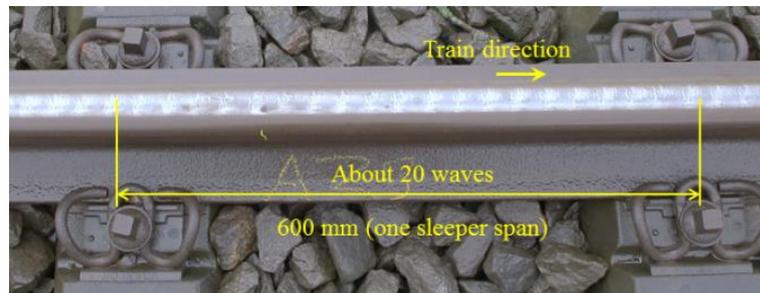
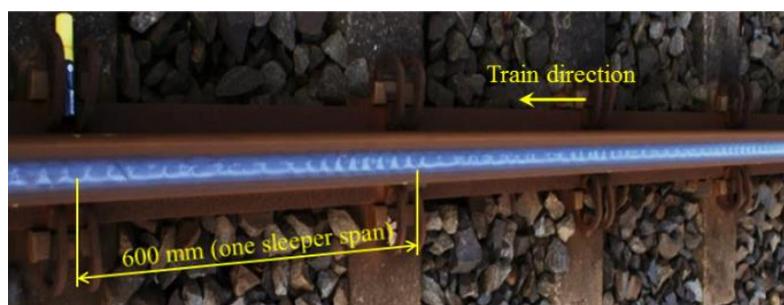
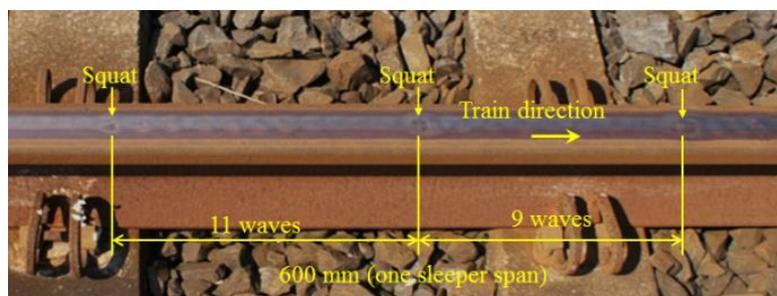
Corrugation mainly occurs on straight tracks or gentle curves where contact does not occur between the wheel flange and rail gauge corner (Figure 1.1), and it usually manifests as shiny ripples and dark valleys. The typical wavelength is in the range of 20–80 mm, with amplitudes up to 100 μm [1]. Corrugation is one of the most prominent problems for railway infrastructure managers because it increases the vibrations of the vehicle-track system and results in higher frequencies (more than 500 Hz) of the wheel-rail dynamic contact forces, which leads to accelerated degradation of vehicle-track system components and shortened service life [5]. In addition, the noise generated by vibrations is a nuisance to residents living near railway lines [1,6]. Because of the high level of noise, corrugation is also known as “roaring rail”. Corrugation can also generate rolling contact fatigue (RCF), such as squats [7] (Figure 1.1c).

The wavelength is 30 mm, which is approximately equal to one of the recorded corrugation wavelengths on the Dutch railway network shown in Figure 1.1a,c (see the measurement in Figure 1.3a). For the analysis, 10 waves are considered; thus, L_2 equals 300 mm. The corrugation considered is located above a sleeper support (as shown in Figure 1.1b), which has been reported as a position where corrugation is more likely to develop [22]. To examine the wheel-rail contact during the growth process of the corrugation, the amplitudes of $A = 0 \mu\text{m}$ for smooth rail and $A = 2.5 \mu\text{m}$, $5 \mu\text{m}$, $10 \mu\text{m}$ and $20 \mu\text{m}$ for corrugated rail are modeled (the peak-to-trough distance is twice the amplitude). By maintaining θ between $-\pi/2$ and π , contact solutions can be studied at different locations within one complete corrugation wavelength, i.e., the falling edge (P1), the trough (P2), the rising edge (P3) and the peak (P4), as shown in Figure 1.3b. Figure 1.3c shows a magnified 3D configuration of the corrugation in the rail surface.

As will be discussed in greater detail in Section 1.4.2 on the prediction of major field observations, the simulated wear in Figure 1.8a is in agreement with the field observations shown in Figure 1.1b,c. Here, the irregular distribution of wear along one sleeper span is clear, and the observations and simulation are in agreement. In the chapter, other agreements between the model results and field observations are discussed in greater detail later in the text. For example, the contact solutions that indicate that wear is the more probable damage mechanism at the corrugation trough [1,11,52] will be described in Section 1.3, and the occurrence of squats in agreement with the observation in Figure 1.1c will be explained in Section 1.4.2. These summaries comprehensively describe and analyze how the model was validated.

Furthermore, the results agree well with the field observations (Figure 1.1). Specifically, the model predicts that the largest wear occurs at 1.23 m above a sleeper centered at 1.2 m (Figure 1.8a). This is in agreement with Figure 1.1c, in which one of the squats was above a sleeper, and with those in Figure 1.1b, where the corrugation was always the most severe above the sleepers. Rails above sleepers have been reported to be more prone to corrugation [22]. The inset in Figure 1.8a shows that the magnitude of wear decreases as the corrugation amplitude increases. This pattern can be understood in relation to Figures 1.6 and 1.7b because the wear is proportional to the product of the shear stress and the slip. The slip at $A = 20 \mu\text{m}$ in Figure 1.7b is generally equal to or less than that at $A = 0 \mu\text{m}$, except at P2. The shear stress at $A = 20 \mu\text{m}$ in Figure 1.6 is always less than that at $A = 0 \mu\text{m}$, and the difference is large for P2 and P3.

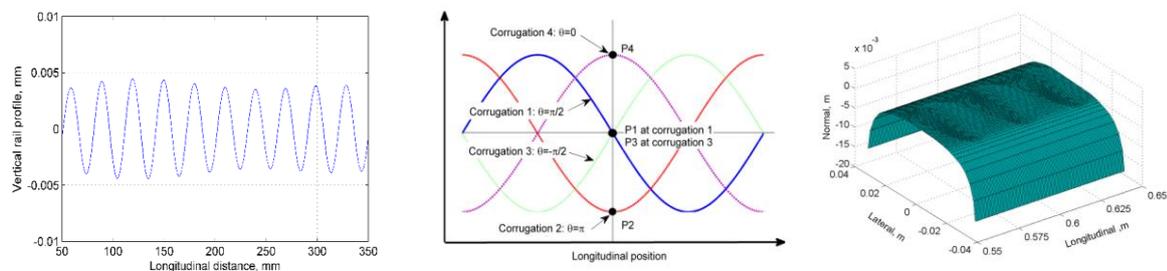
Figure 1.3 Modeled corrugation: (a) field measurement of corrugation (27–33 mm bandpass filtering); (b) schematic diagram of the corrugation and 4 positions (blue line: P1, red line: P2, green line: P3 and magenta line: P4); and (c) illustration of the applied corrugation (Corrugation 2 with P2 at 0.6 m) in the rail surface with 5× magnification (only 3 complete waves are plotted).

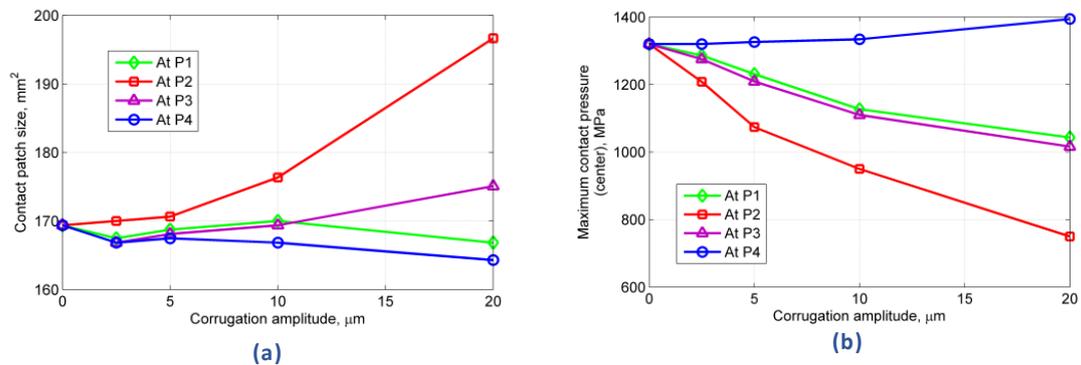
Figure 1.4a shows the changes in the contact patch size at P1, P2, P3 and P4 with increasing amplitude A . Compared with $A = 0 \mu\text{m}$, an increase in size of up to 16% at P2 is observed in the case of $A = 20 \mu\text{m}$, and the increase is approximately 4% at P3. At the other two positions, the changes are minor. The maximum contact patch size is approximately 200 mm^2 ($A = 20 \mu\text{m}$) at P2, i.e., the corrugation trough, whereas it is approximately 170 mm^2 when the rail is smooth. Figure 1.4b displays the maximum contact pressure along the longitudinal axis ($y = 0 \text{ mm}$) for different corrugation amplitudes A . As the corrugation amplitude increases from 0 – $20 \mu\text{m}$, the contact pressure at P2 drops significantly to 56% of the original level, i.e., from 1320 – 745 MPa . This decrease is partly because of the 15% increase in the contact patch size (Figure 1.4a). At P1 and P3, the maximum pressure declines slightly to 78% of the original level. An increase in pressure of 6% is observed at P4 for the case of $A = 20 \mu\text{m}$.

Figure 1.4. Influence of corrugation amplitude on the size of the contact patch and the maximum contact pressure along the longitudinal axis $y = 0$ mm. (a) Contact size; (b) contact pressure.

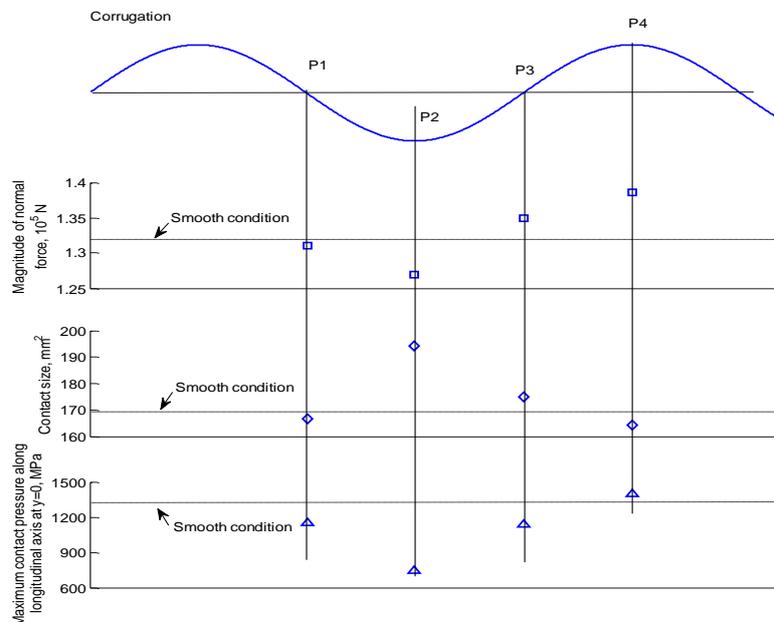
Figure 1.5 shows a typical profile of the variation of the magnitude of normal force, contact size and maximum contact pressure along the longitudinal axis. In the figure, the typical normal force is the lowest at trough P2 and the highest at peak P4, with intermediate values at points P1 and P3. As the corrugation amplitude increases, the normal contact force at P2 decreases and the area of the contact patch increases; thus, the pressure decreases. At P4, the normal contact force increases, and the area of the contact patch decreases; thus, the pressure increases. At P1 and P3, the normal contact force and the area of the contact patch are intermediate between cases P2 and P4. These patterns are further evident in Figure 1.4b, where the maximum contact pressure of P1 and P3 for the different corrugation amplitudes decreases, although it does not decrease as strongly as in the case of P2.

Figure 1.5. Magnitude of the normal force contact size and maximum pressure along the longitudinal axis at ($y = 0$ mm) at the four analyzed positions P1, P2, P3 and P4 ($A = 20 \mu\text{m}$).

As also shown in Figure 1.5, the pressure variation within a corrugation wavelength along the longitudinal axis $y = 0$ mm is approximately in phase with the corrugation. Furthermore, the shapes of the contact patch differ from those under the smooth rail condition. Part of the contact patch is not present in the leading area at P1, in the trailing area at P3 and in both the leading and trailing areas at P2 and P4. Thus, the deviation from a Hertzian solution is large and further exacerbated by increases in the corrugation amplitude.

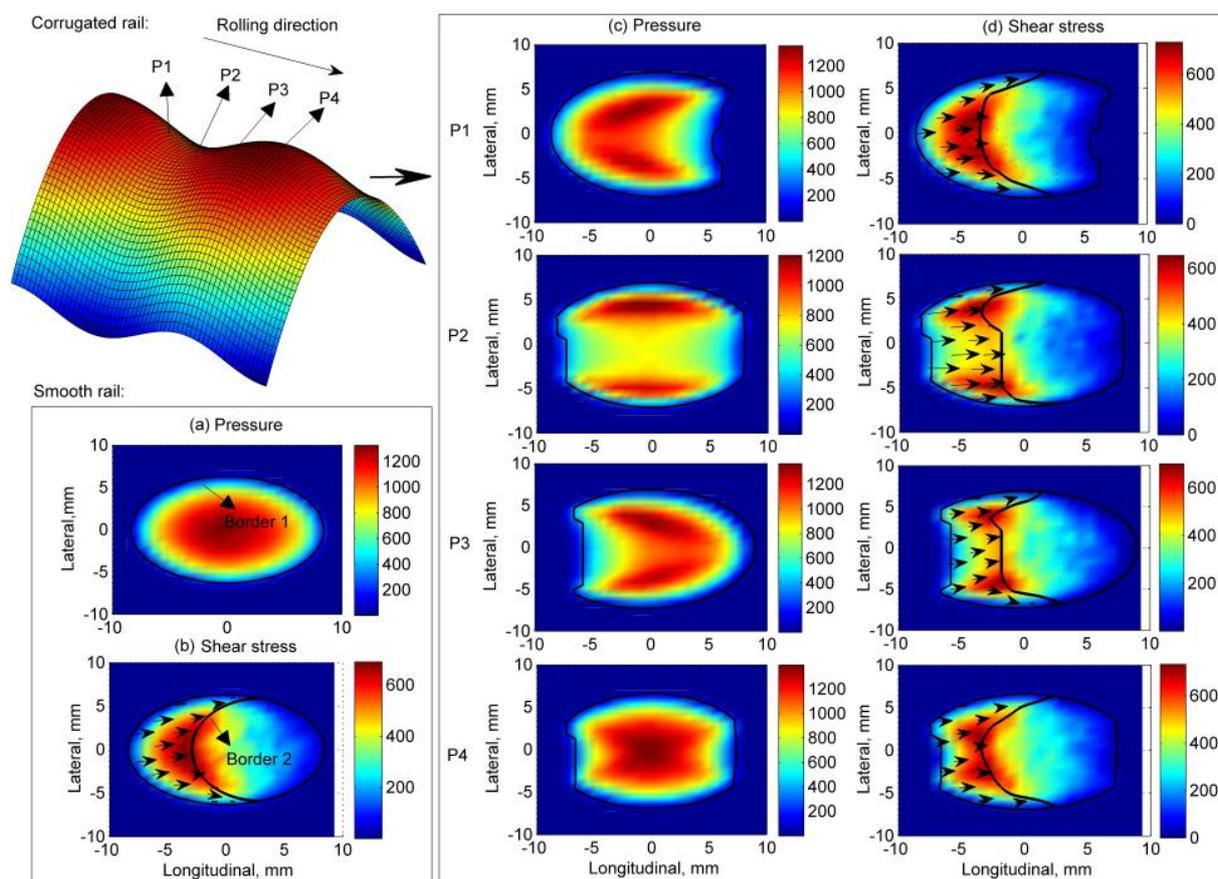
Figure 1.6 shows the projections of contact pressure and shear stress onto the xOy plane, the shape of the contact patch under the smooth condition and the evolution within one corrugation wavelength from P1 to P4 when $A = 20 \mu\text{m}$. Most shapes are not elliptic and thus differ from the Hertzian solution. Because of the downhill slope of the corrugation at P1, a large drop in pressure is observed at the leading edge of the contact patch and vice versa at P3. Thus, the pressure distributions at P1 and P3 take the shapes of a “waning crescent moon” and “waxing crescent moon”, respectively. At P2, the maximal pressure shifts to the field and gauge sides, thereby decreasing the contact pressure in the contact patch center to 600–800 MPa. The pressure distribution at P4 is close to the solution under

Figure 1.6. Contact pressure, shear stress, contact patch, adhesion-slip distributions and vector graphs of micro-slips (vectors in Figure 1.6b,6d) when $A = 20 \mu\text{m}$ along one corrugation wavelength (P1–P4) (projection onto the xOy plane; Border 1: contact patch border; Border 2: adhesion-slip distribution border).

The adhesion-slip distribution in the presence of corrugation is shown in Figure 1.6d. The boundary between the adhesion and the slip zones at P2 and P3 is far from elliptic [14]. As assumed, differential wear proportional to the frictional work [9,18,22] causes the development of corrugation. Frictional work only occurs in the slip zone. Therefore, the size of the slip zone in the contact patch, as well as the magnitude of the slip might be indicators of corrugation development.

indicate that large micro-slips in the trough could be a major driver of corrugation development. The distribution of the slip within the contact patch is shown in Figure 1.6b,d.

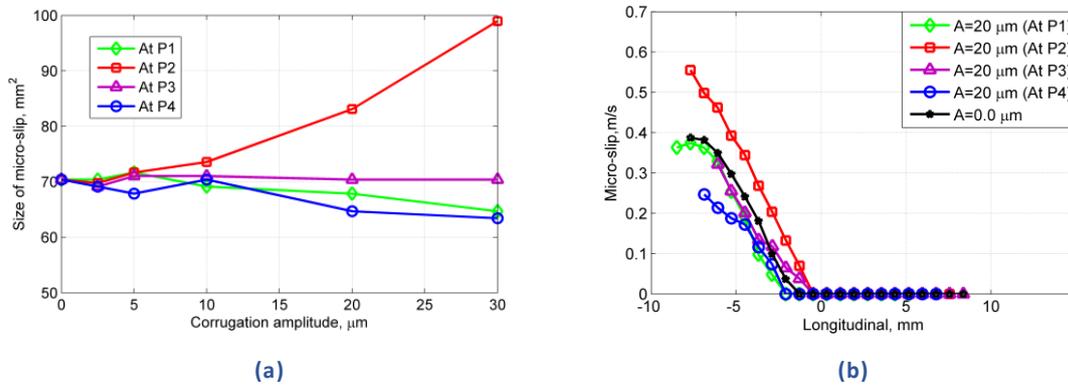
Figure 1.7. Size of the slip zone as a function of the corrugation amplitude and slip distribution along the longitudinal axis $y = 0$ mm at the four positions. (a) Size of slip zone; (b) slip along the longitudinal axis $y = 0$ mm.

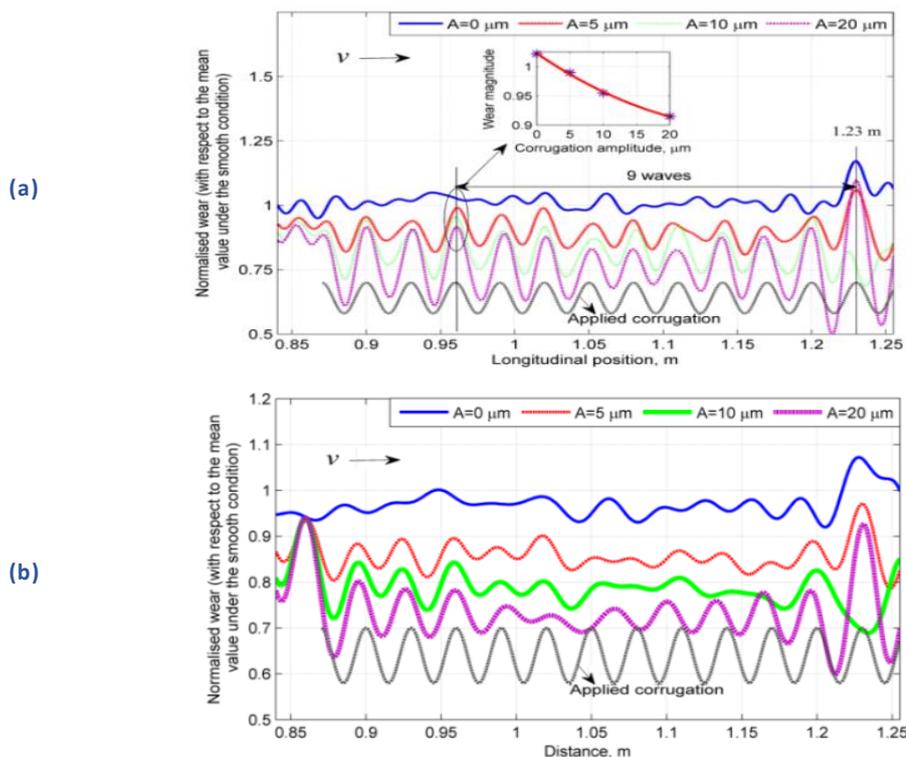
The wear along the longitudinal axis $y = 0$ mm is studied. Figure 1.8a (which mentioned in Section 1.2.3) shows the distribution of the simulated wear along the rail with different corrugation amplitudes for the P4 corrugation position of $\theta = 0$, with 1.2 m as the corrugation peak. The results for the other corrugation positions show similar trends and are not presented. The wear is not uniform along the rail; thus, corrugation development will not be uniform under the evaluated conditions. Comparing the field observations in Figure 1.1 with the wear simulation results in Figure 1.8a reveals that the model closely reproduces the conditions in Figure 1.1b,c in terms of predicting the periodicity of the wear and the number of corrugation waves in the periodicity. The periodicity in Figure 1.1c is nine and 11 waves. The periodicity in Figure 1.8a is nine waves between the largest peak-to-trough wear magnitudes at 0.96 m and 1.23 m. In Figure 1.1c, the periodicity is counted between the squats because the squats should have been caused by the most severe corrugation, i.e., the largest wear.

Figure 1.8. Distribution of wear at different corrugation amplitudes obtained for the corrugation in Figure 1.3b with $\theta = 0$ and P4 at 1.2 m. The middle of a sleeper is at 1.2 m, and the midpoint between two sleepers is at 0.9 m. (a) High-pass filtered at $\lambda = 20$ mm. (b) High-pass filtered at $\lambda = 30$ mm.

The wear in Figure 1.8a is of the same wavelength and phase as the modeled corrugation. Thus, the existing corrugation will be erased by wear and will not grow, and if the rail is smooth, no corrugation will initiate. This finding is reasonable because the simulation is based on nominal track parameters; in reality, many tracks are indeed free of corrugation. Thus, the results indicate that corrugation is sensitive to the system parameters, e.g., rail fastening [41].

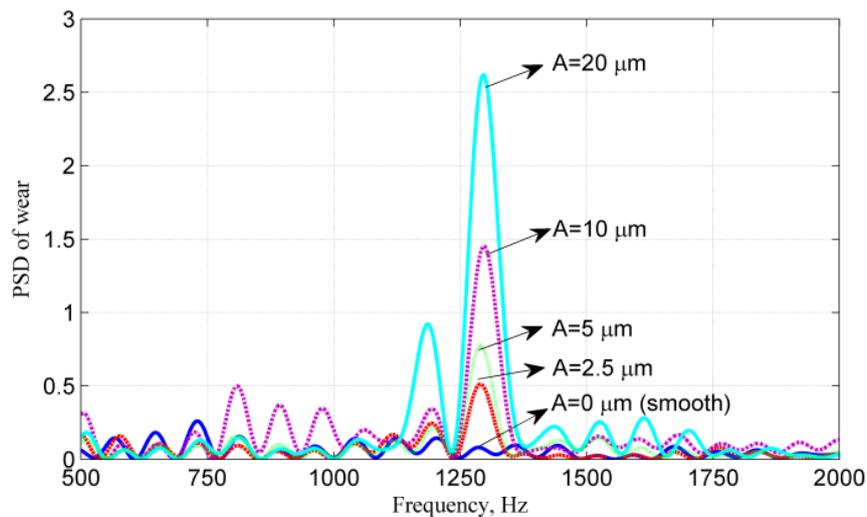
Figure 1.9 shows the power spectra of the calculated wear under different corrugation amplitudes. When $A = 20 \mu\text{m}$, a major frequency component is observed at approximately 1296 Hz, approaching the corrugation passing frequency of 1297 Hz (estimated with a wheel passing at 38.9 m/s over the corrugation with a wavelength of 30 mm). When A is reduced, this major frequency also decreases. At $A = 2.5 \mu\text{m}$, the frequency is 1290 Hz, which is 7 Hz lower. Thus, the frequency of the wear is initially (i.e., when A is small) lower than that of the modeled corrugation, and it is influenced by the corrugation.

Figure 1.9. Power spectral density (PSD) of wear $\lambda = 30$ mm, with a major peak at 1296 Hz and a secondary peak at 1185 Hz, when $A = 20$ μm .

When A is increased to 20 μm , there is a sudden PSD increase at 1185 Hz; see the second major peak in Figure 1.9. Modal analysis in Figure 1.10a,b shows that these two major frequencies of 1185 and 1296 Hz correspond to two natural frequencies of the system (1185 Hz of a vertical rail mode and 1291 Hz of a longitudinal rail mode), i.e., the two natural frequencies that are closest to and/or lower than the corrugation passing frequency of 1297 Hz (see in Figure 1.10 the characteristic modal shapes). The closest pin-pin resonance is at approximately 1110 Hz (Figure 1.10c), and it thus does not seem to have influence on the wear development in this case.

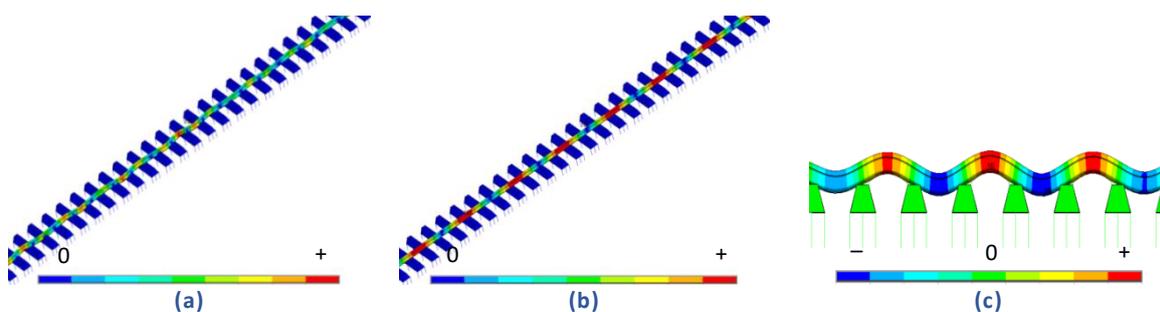
Figure 1.10. Modal analysis of the two major frequencies (1185 and 1296 Hz) shown in Figure 1.9: (a) rail vertical mode at 1185 Hz and (b) rail longitudinal mode at 1291 Hz, in comparison with the closest vertical pin-pin mode at 1100 Hz shown in (c).

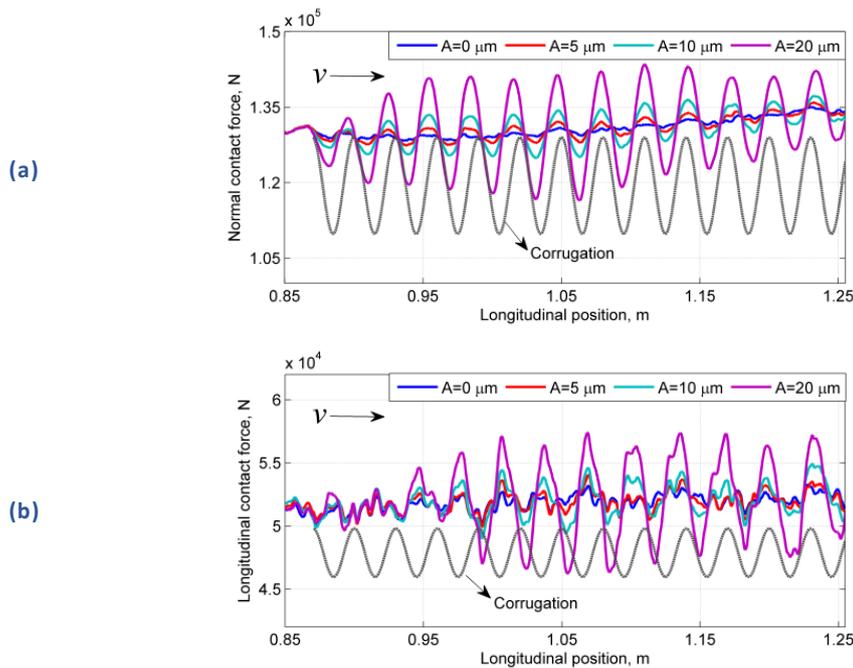
Figure 1.11 shows the normal contact force (F_N) and longitudinal contact force (F_L) when the rail is smooth and when corrugation is present. Although the wavelength of the modeled corrugation is constant (30 mm), the wavelengths of the resulting dynamic wheel-rail contact forces vary along the rail (Figure 1.11a). Specifically, F_N initially lags behind the corrugation, i.e., the peak of F_N appears to the left side of the corresponding corrugation peak. When approaching the sleeper, which has a width of 140 mm and is centered at 1.20 m, the force catches up and becomes in phase with the corrugation at approximately 1.1 m, i.e., near the edge of the sleeper. The force subsequently tends to lead the corrugation. A similar situation applies to F_L (Figure 1.11b). However, F_N leads F_L initially, and the two forces later tend to be in phase at approximately 1.23 m, with subsequent lagging of F_N . Note that the wear is also strongest at approximately 1.23 m (according to Section 1.4.2).

Figure 1.11. Dynamic wheel-rail contact forces obtained for the corrugation in Figure 1.3 with $\theta = 0$ and P4 at 1.2 m (1.2 m is in the middle of a sleeper and 0.9 m is at the midpoint between two sleepers.). (a) Normal contact force. (b) Longitudinal contact force.

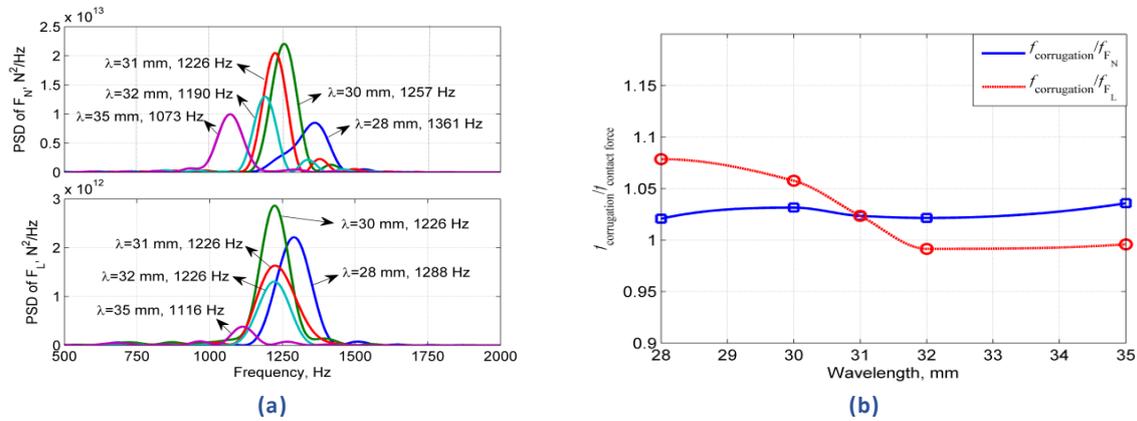
Figure 1.12. Relationships between the PSD and frequencies of the contact forces and corrugation wavelength obtained for the corrugation in Figure 1.3b with $\theta = 0$, P4 at 1.2 m and $A = 20 \mu\text{m}$. Note that in (b), $f_{\text{corrugation}}$ is not constant, but changes with the corrugation wavelength. Thus, although the PSD of FL varies in a narrower band than FN in (a), the opposite pattern is observed in (b). (a) PSD of FN (upper) and FL (lower). (b) Ratio of corrugation over contact force frequency.

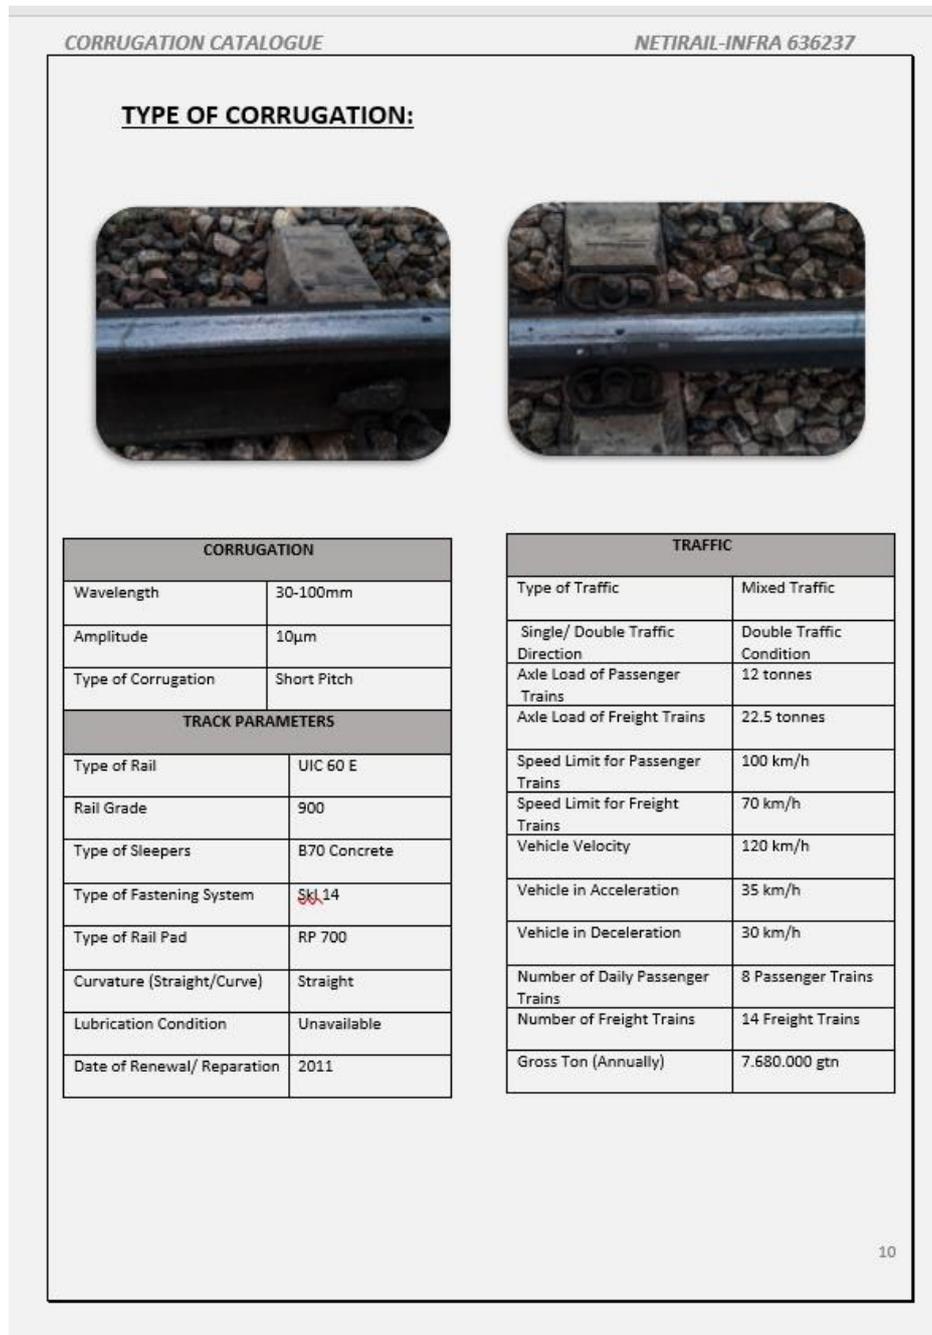
Figure 2.2.1 An example of TCDD corrugation catalogue (short-pitch corrugation)

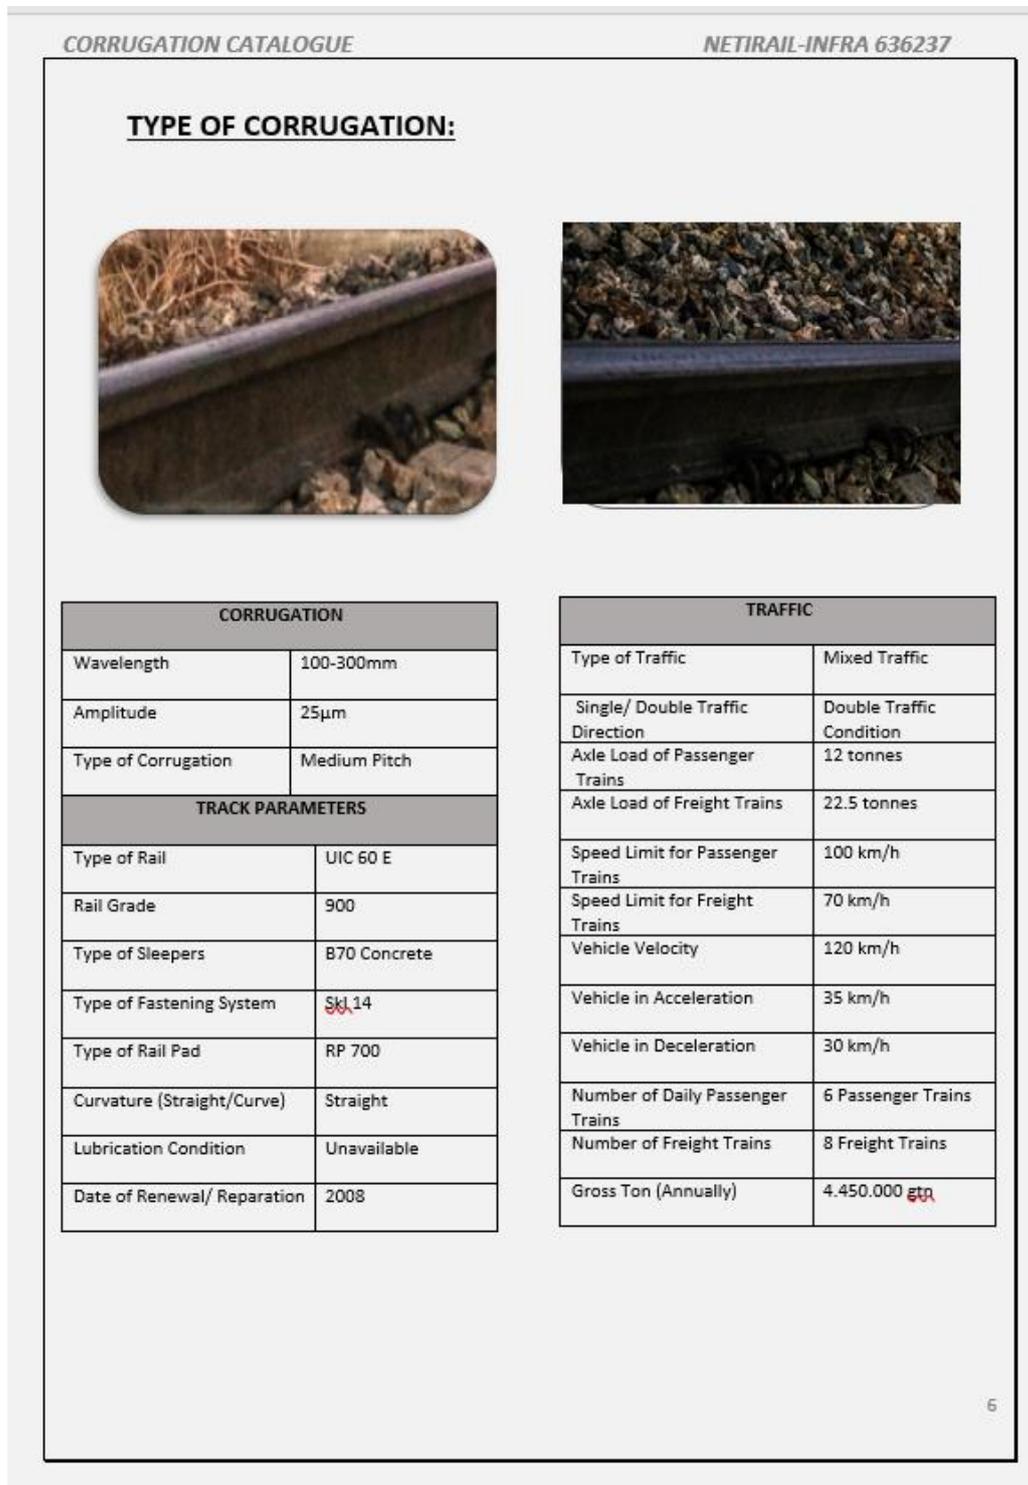
Figure 2.2.2 An example of TCDD corrugation catalogue (medium pitch corrugation)

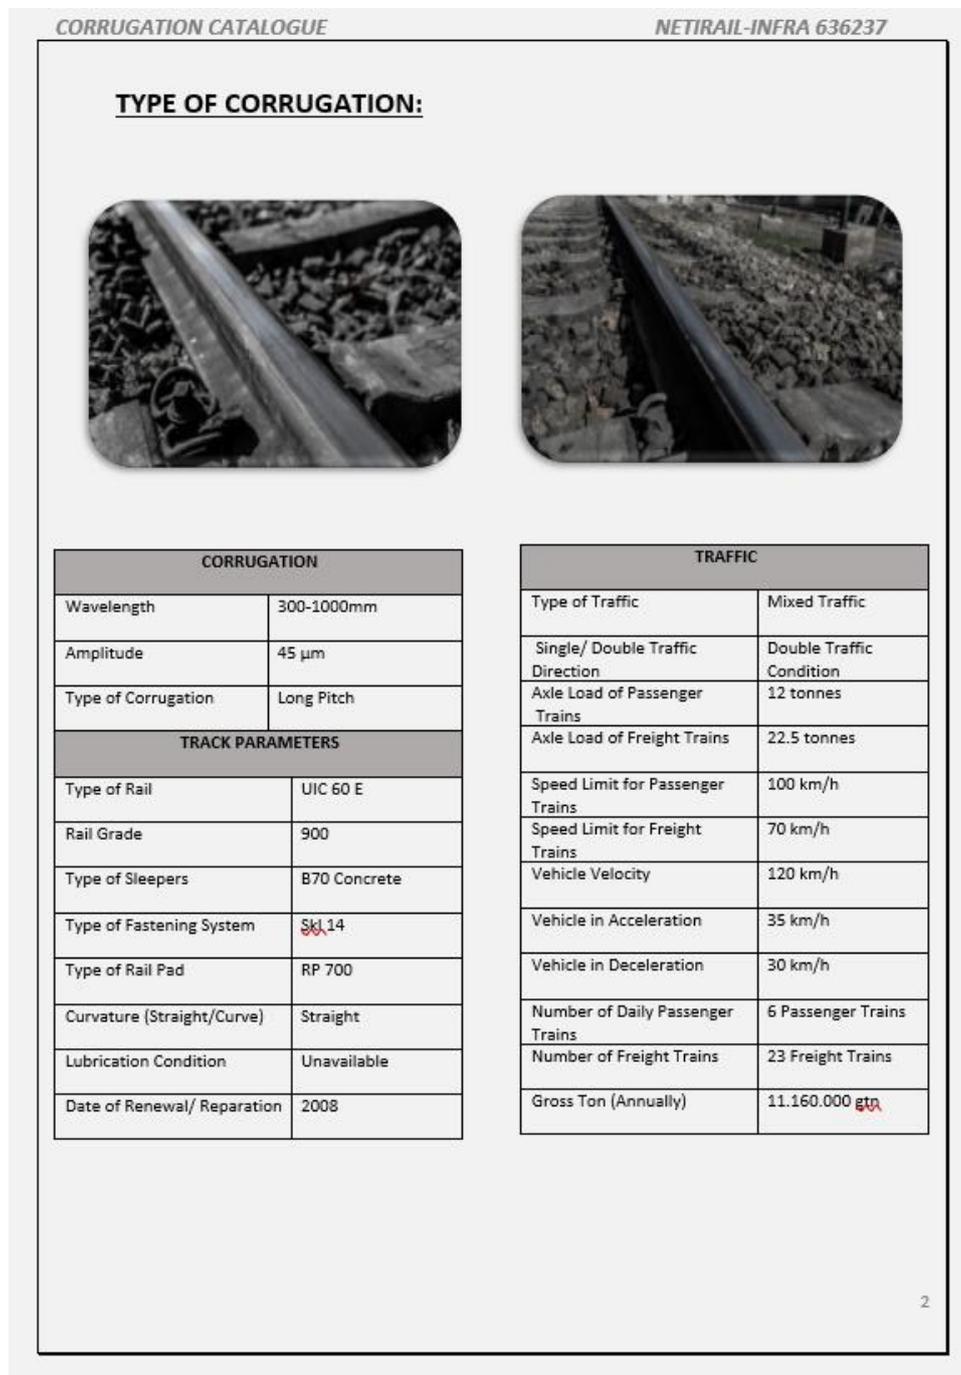
Figure 2.2.3 An example of TCDD corrugation catalogue (long pitch corrugation)

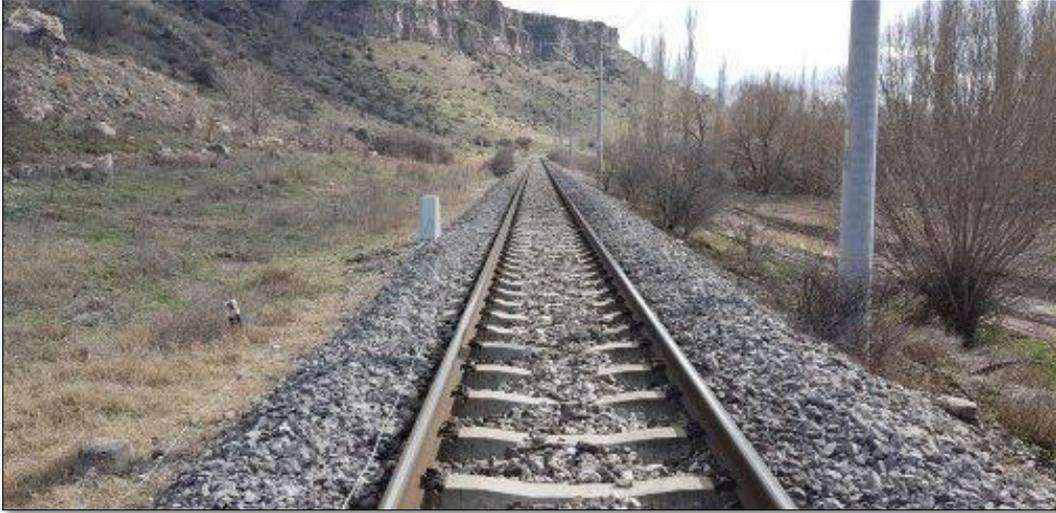
Figure 3.1.1 Selected test site (Eskişehir- Afyon- Kütahya Line)

Eskişehir- Kütahya- Afyon line type is a conventional one. The exact test location is determined as 17+800 km near to Kızılınler, very close to Eskişehir. A photo and open railway map picture of test site are given in Figure 3.1.1 and Figure 3.1.2. respectively.

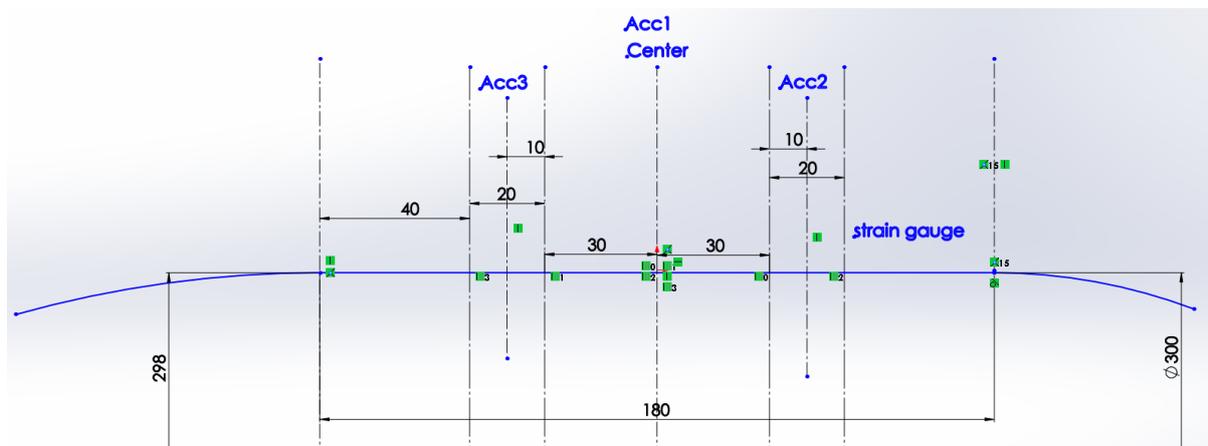
The test site is determined as 180 m long in a plain line that connects two curves. The unscaled representation of the test site is shown in Figure 3.1.3. The first curve on Eskişehir line has a radius of 298 m, the second curve on Kütahya line is 300 m.

Figure 3.1.3 Unscaled representation of the test line

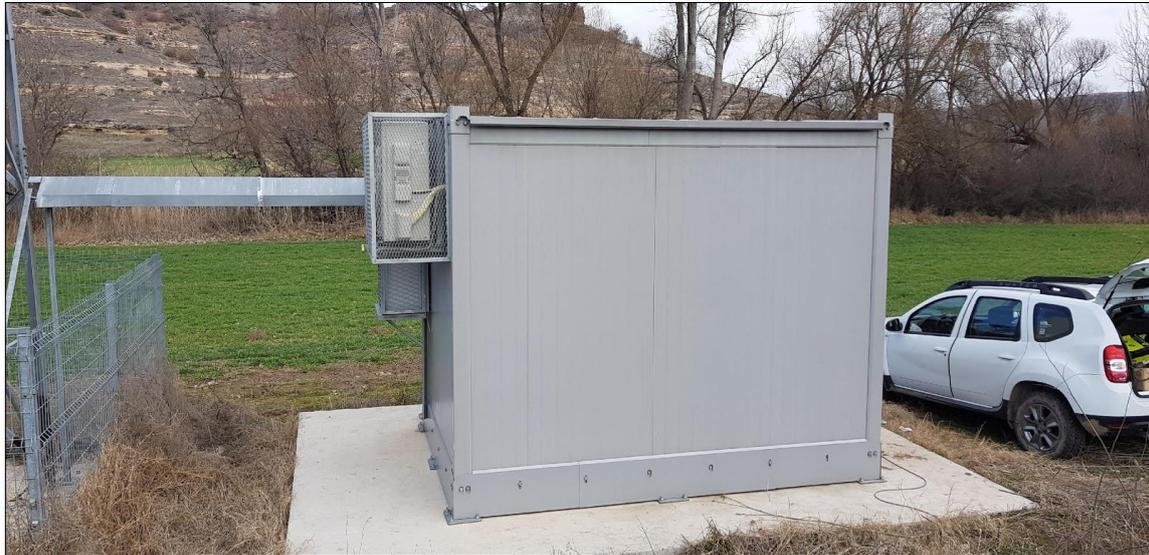
As mentioned before, the line is electrified, however, the nearest voltage supply to connect the test equipment is the signal cabinet for the passing trains and it is 900 m away from the test site as demonstrated in Figure 3.1.4. To clarify, a photo taken by the existing signalization cabinet, as origin point is given ,in Figure 3.1.5, to understand the distance between the test location and the cabinet. Because of the long distance, to provide power to our equipment, we had to lay almost 1 km cable. The laid cable was spanned to the data logger cabinet with a IP 65 junction box. Since signalization has a vital importance for TCDD to enable the continuity of the transportation, with the connected cable, we were able to provide 10 hours uninterruptable power for our equipment. However, during the first trial of the test, we could not get any alive data because of low quality of Wi-fi connection. The reason is the test site was located in a rural area where the mountains are enclosed so that the 3G signal is rather low comparing to outskirts of Eskişehir. Another important issue is the distance between the power supply and the test location is really far and the laid cable was exposed to the environment. Any extreme change in weather, animal contact (gnawing animals or wild animals) or person contact (workers of TCDD or unknown persons) has a high possibility to interrupt the system. Unfortunately, because the test designed as its nature as a not closed system, we had to take these risks during the test.

Figure 3.1.4 The signalization cabinet used for supplying electricity (220 V) to the test equipment

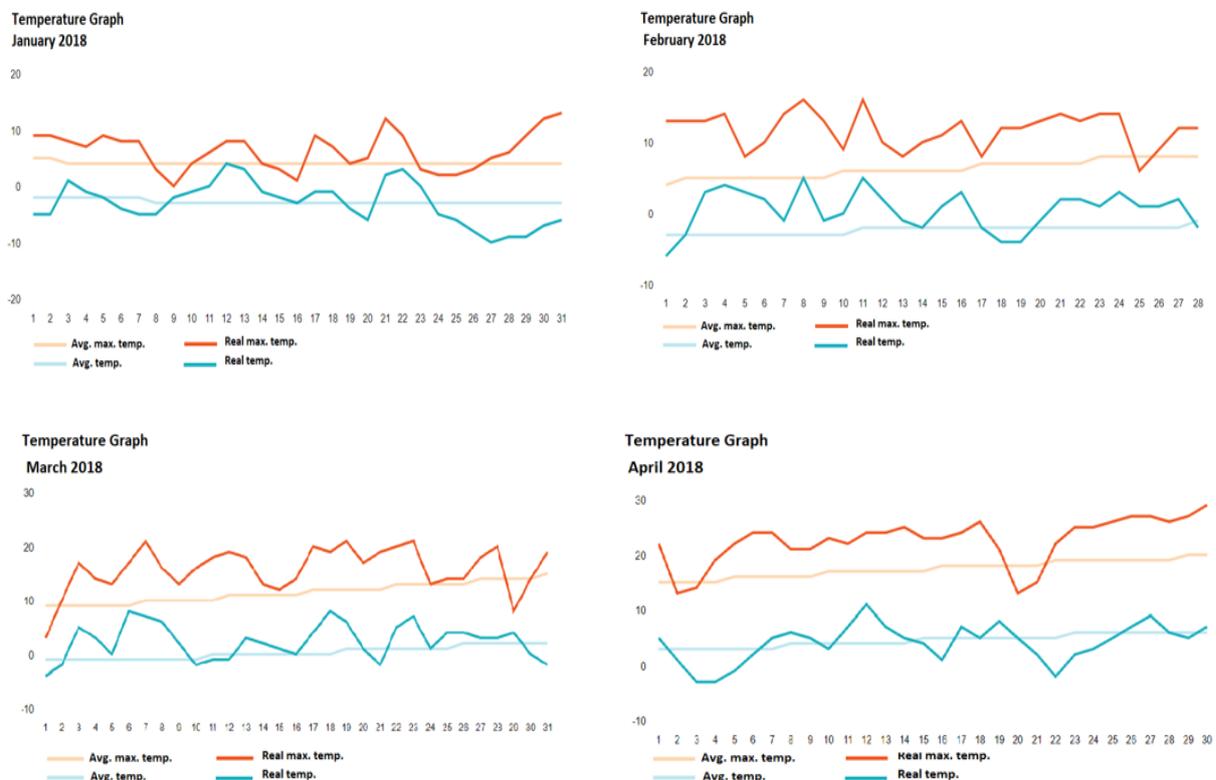
During the validation of the test, the temperature graphs of the Eskişehir was given in Figure 3.1.6. The temperature of test site differs form -10°C to 40°C, with heavy rain and snow.

Figure 3.1.6 Temperature values during the validation of the test site [4]

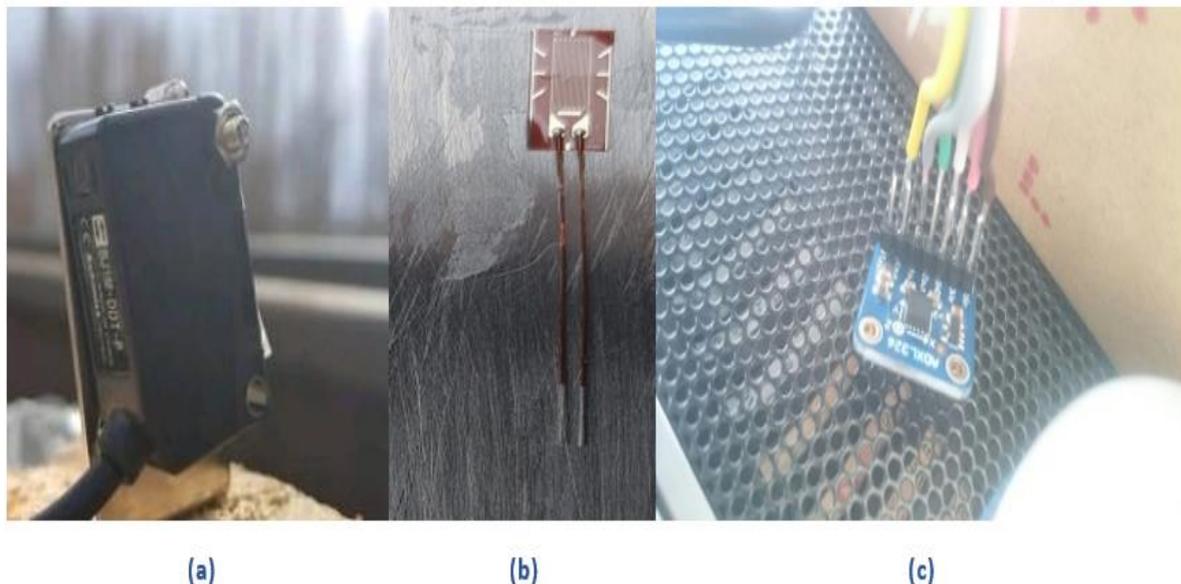
Figure 3.2.1. (a) Laser sensor for speed calculation; (b) Strain gauge (before commissioning); (c) ADXL326 Mems based accelerometer

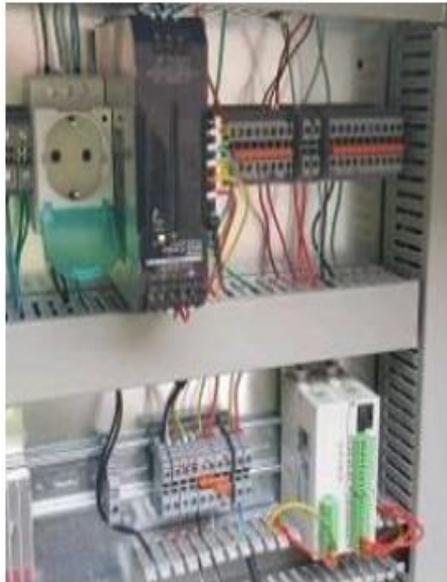
Figure 3.2.2. (a) Integration of the equipment in a board; (b) Demonstration of remote access to the data logger

The equipment used for the corrugation tests are explained in below. A few examples of the equipment are given in Figure 3.2.1 and Figure 3.2.2.

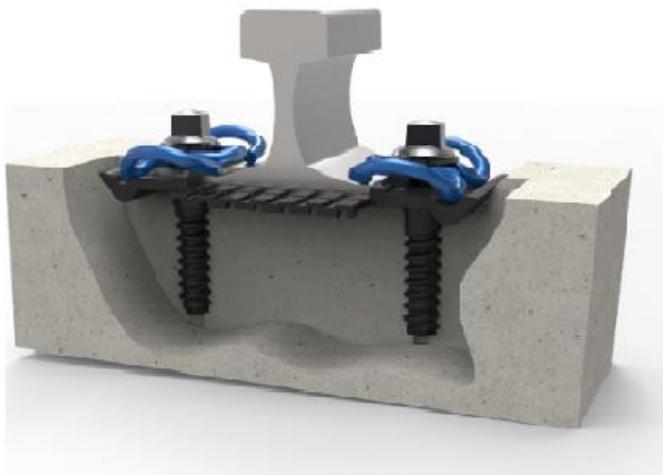
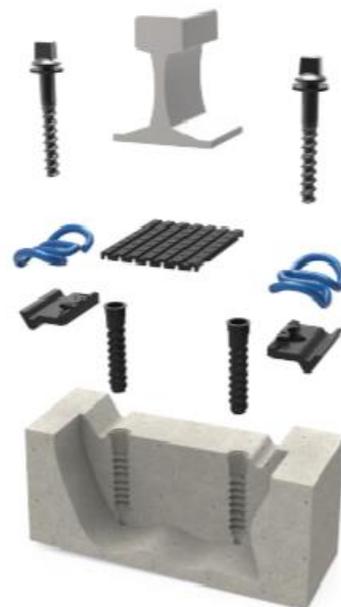
Figure 3.2.3. W14 for high speed and conventional lines

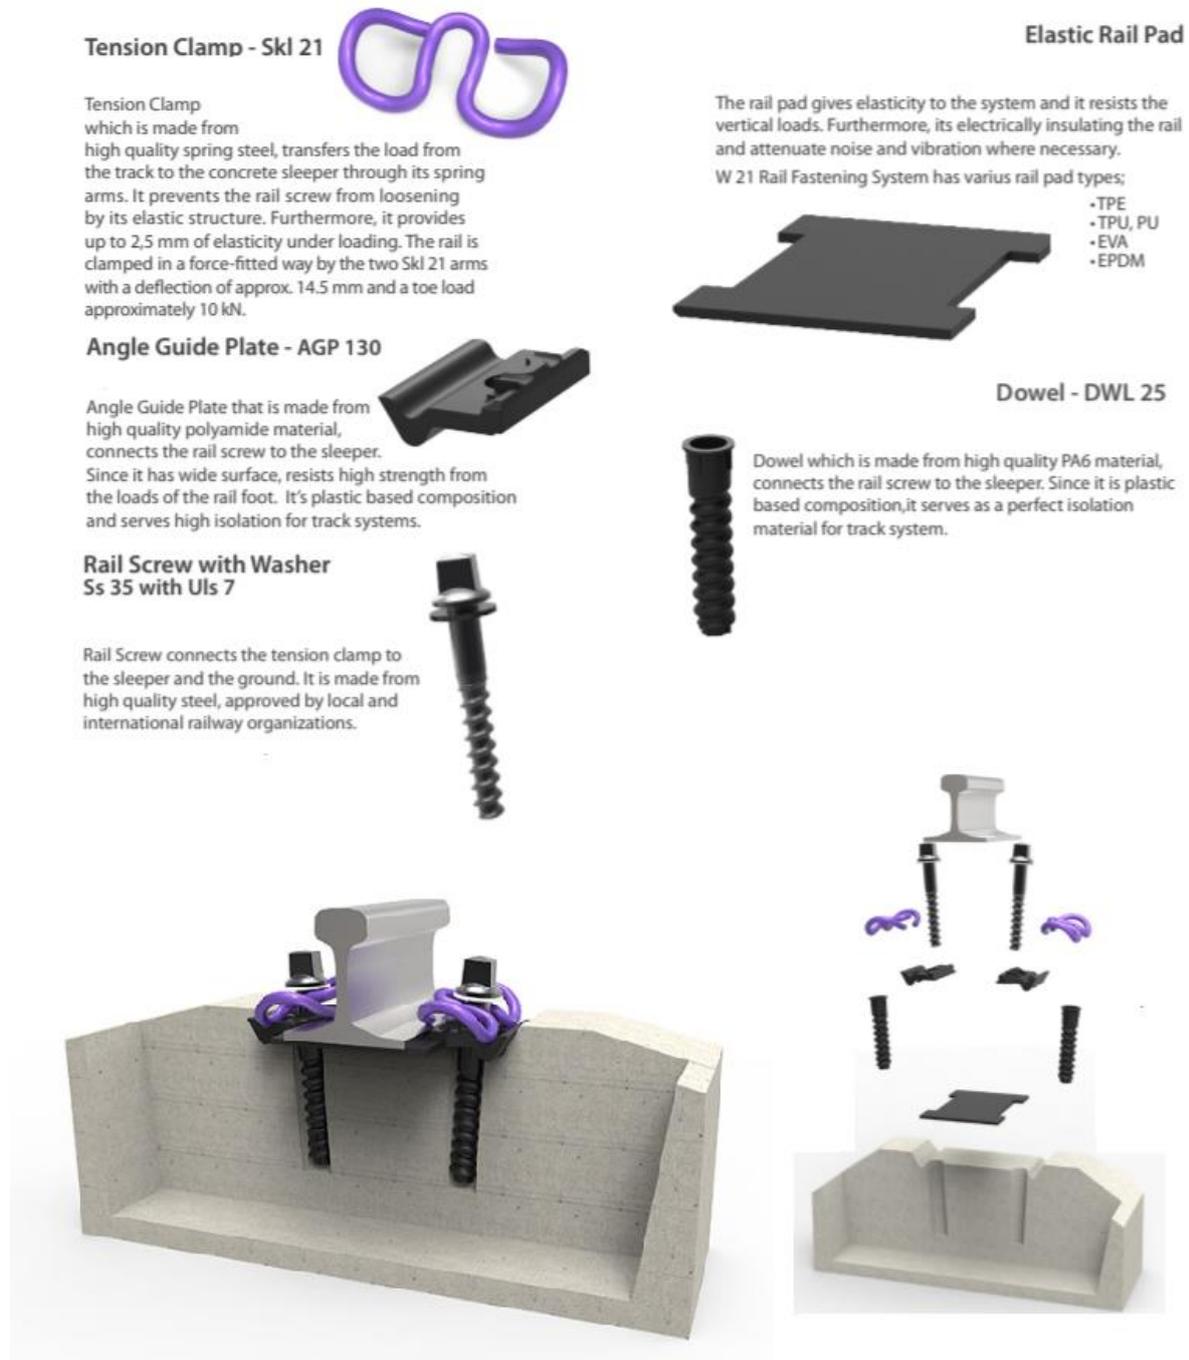
Figure 3.2.4. W21 for high speed and conventional lines

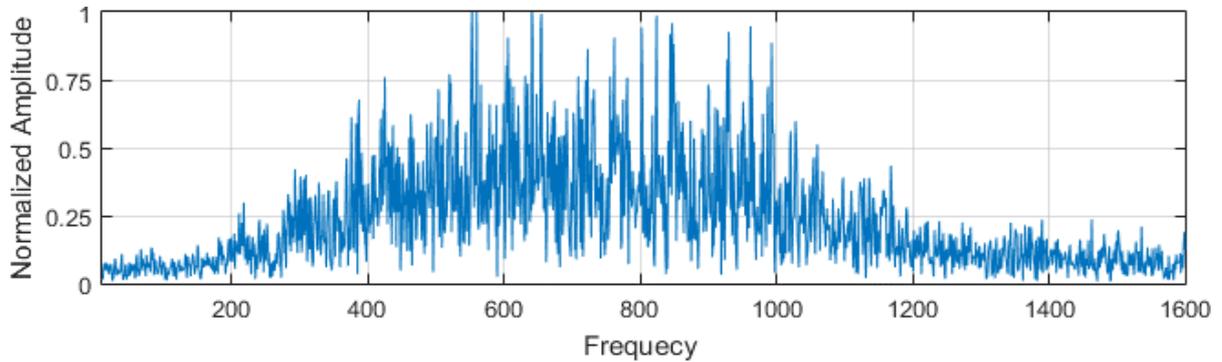
Figure 3.4.1.1. W14 fastening system results for passenger trains

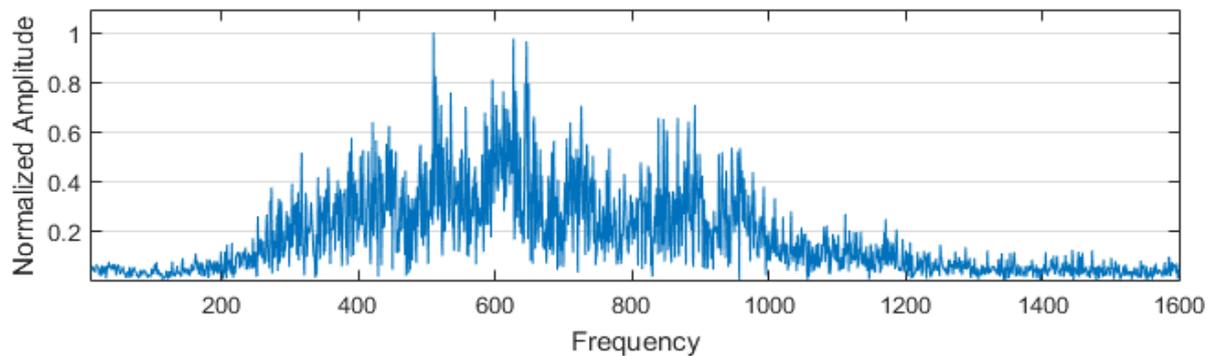
Figure 3.4.1.2. W21 fastening system results for passenger trains

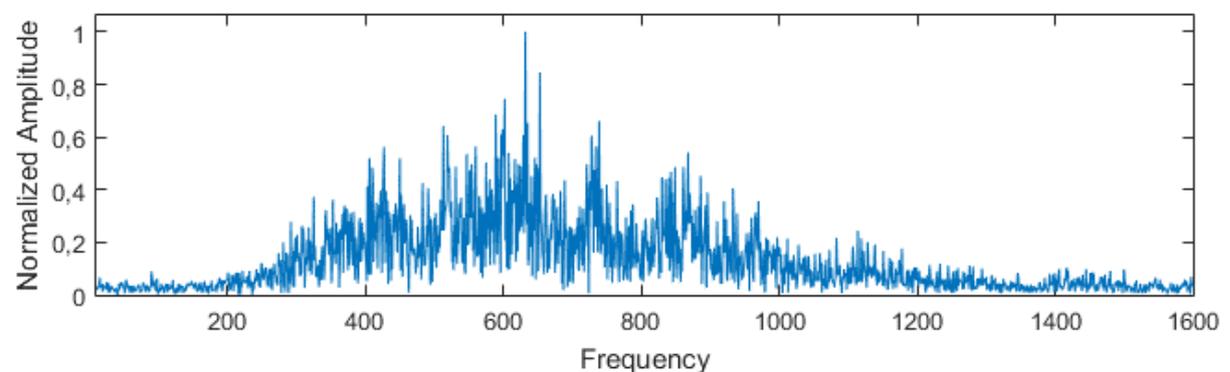
Figure 3.4.1.3. HH fastening system results for passenger trains

As a conclusion, W14 and W21 give almost similar results while HH seems to be the most unsuitable pad. It is essential to remember that the test duration is less than one year so that the elasticity of the plastic pads and durability of the fastening components, as well as their impact on the system, could not be observed. It is a fact that these systems are open to the environment and highly affected from the weather conditions that may change their durability, usage time, stiffness value (depending on type) and their connection distance. In addition, although the speed restrictions are identified for TCDD lines during the test, it was observed that sometimes the trains were over the speed limits. Therefore, it is also an unignorable fact that the results may be affected the variations in high speed. Finally, the seasonal effects and speed variation on the fastening system and plastic pads can be another research topic while taking into account the current research.
