Needs Tailored Interoperable Railway Infrastructure

Deliverable D2.6

Tailoring track to avoid corrugations: Traffic dependant selection of rail cross-section, clips and pads to avoid or delay corrugation

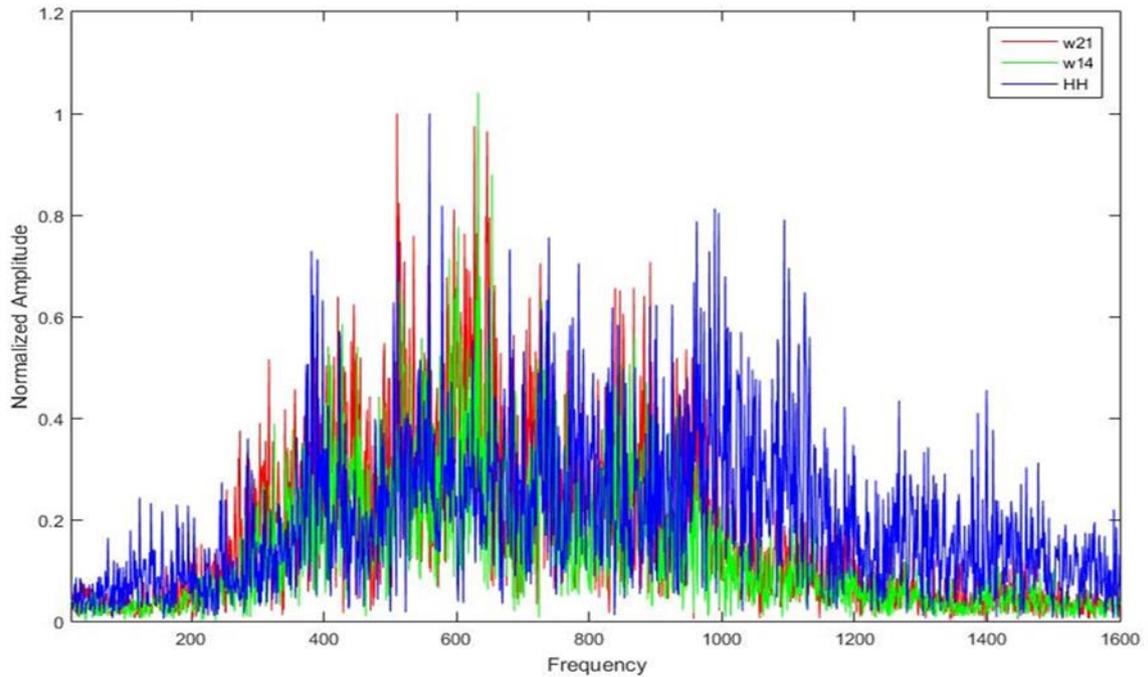
Figure 3.4.1.4. Comparison of fastening systems the results for passenger trains

As a conclusion, W14 and W21 give almost similar results while HH seems to be the most unsuitable pad. It is essential to remember that the test duration is less than one year so that the elasticity of the plastic pads and durability of the fastening components, as well as their impact on the system, could not be observed. It is a fact that these systems are open to the environment and highly affected from the weather conditions that may change their durability, usage time, stiffness value (depending on type) and their connection distance. In addition, although the speed restrictions are identified for TCDD lines during the test, it was observed that sometimes the trains were over the speed limits. Therefore, it is also an unignorable fact that the results may be affected the variations in high speed. Finally, the seasonal effects and speed variation on the fastening system and plastic pads can be another research topic while taking into account the current research.

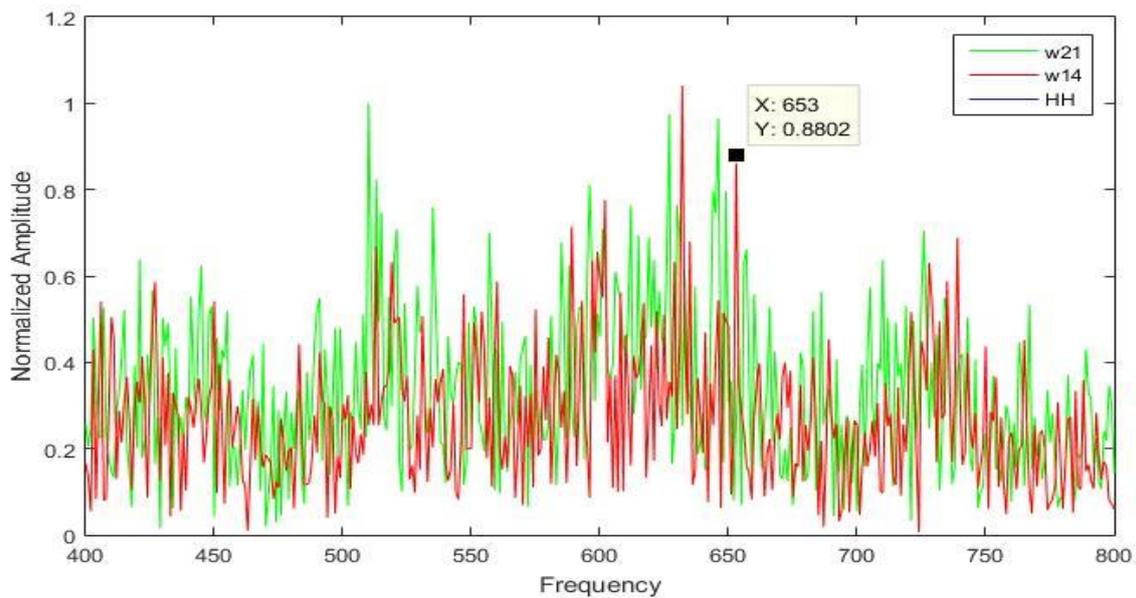
Figure 3.4.1.5. Comparison of W14 and W21 fastening systems for passenger trains

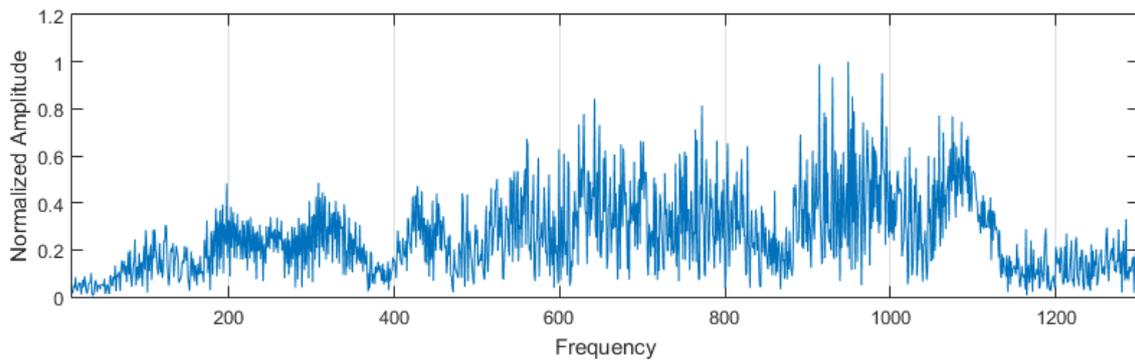
Figure 3.4.2.1. HH fastening system results for freight trains

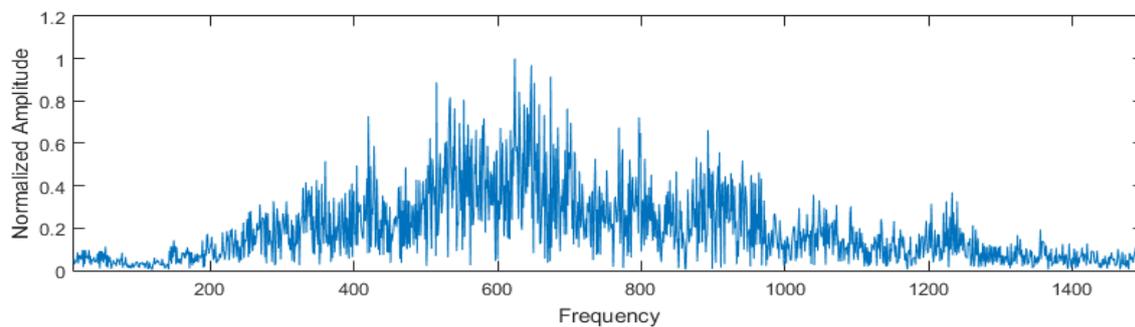
Figure 3.4.2.2. W21 fastening system results for freight trains

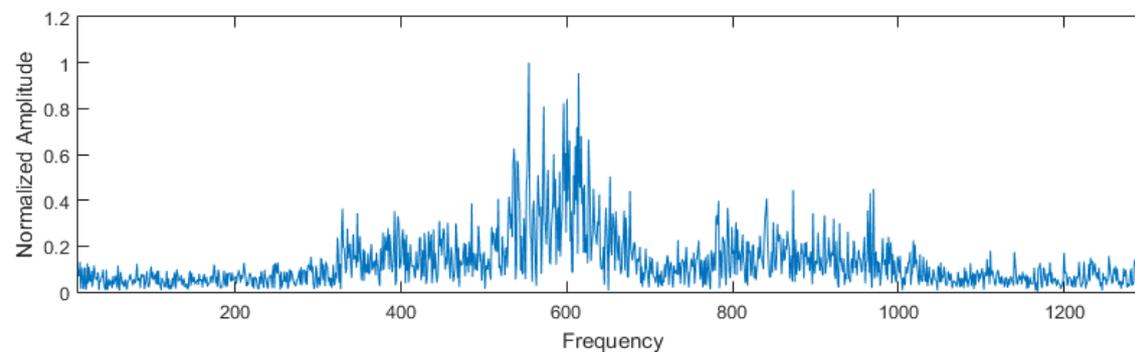
Figure 3.4.2.3. W14 fastening system results for freight trains

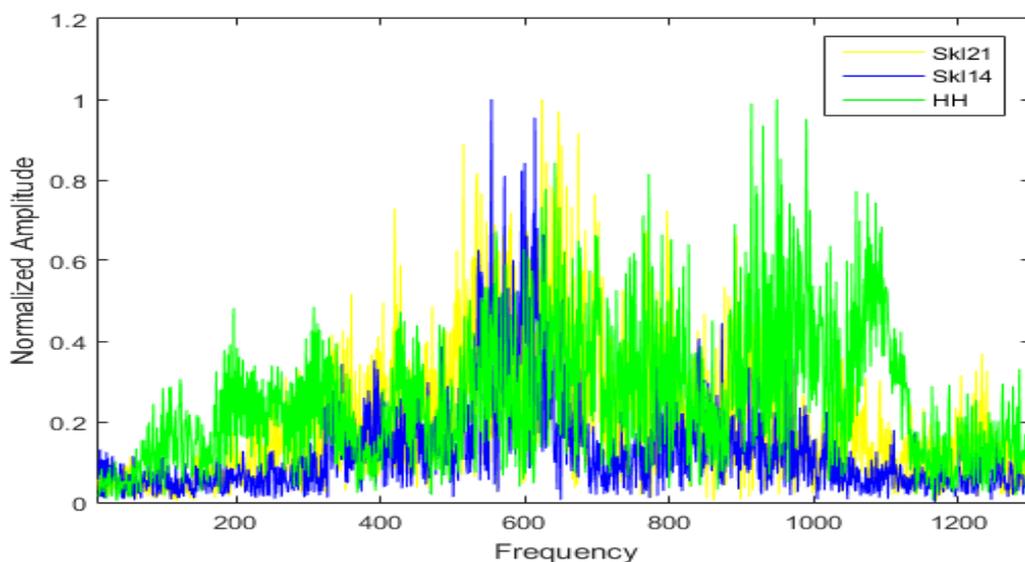
In Figure 3.4.2.4., three systems were combined and demonstrated as one graph to detect the most effective fastening system by normalizing the amplitude. As seen in the figure, HH has the highest frequency rating and it has higher amplitudes over the whole range.

Figure 3.4.2.4. Comparison of fastening systems the results for freight trains

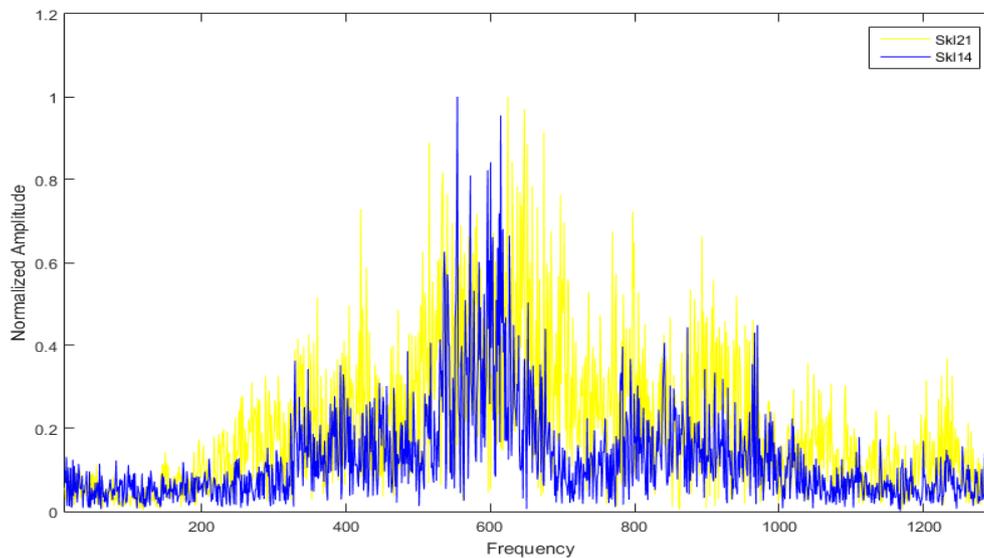
To differentiate the difference between W14 and W21, HH was taken out from the graph. The results for W14 and W21 are demonstrated in Figure 3.4.2.5. According to our results and as well as can be seen from below figure, W14 demonstrated a better performance comparing to W21. On the other hand, W14 has a narrower band contrary to W21 which has a wider frequency range. However, the results of both fastening systems are quite similar to each other.

Figure 3.4.2.5. Comparison of W14 and W21 fastening systems for freight trains

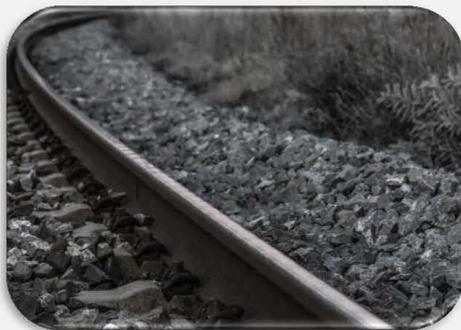
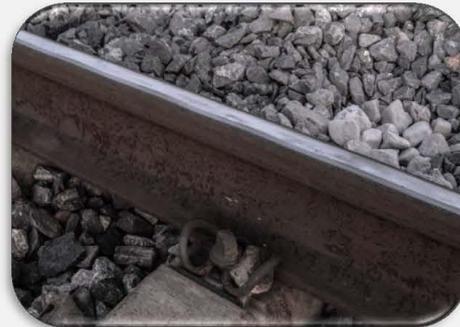
CORRUGATION	
Wavelength	300-1000mm
Amplitude	55µm
Type of Corrugation	Long Pitch
TRACK PARAMETERS	
Type of Rail	UIC 60 E
Rail Grade	900
Type of Sleepers	B70 Concrete
Type of Fastening System	Skl 14
Type of Rail Pad	RP 700
Curvature (Straight/Curve)	Curve
Lubrication Condition	Unavailable
Date of Renewal/ Reparation	2009

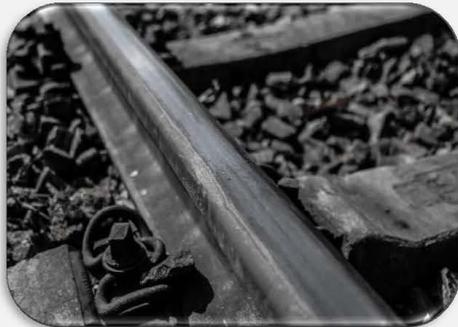
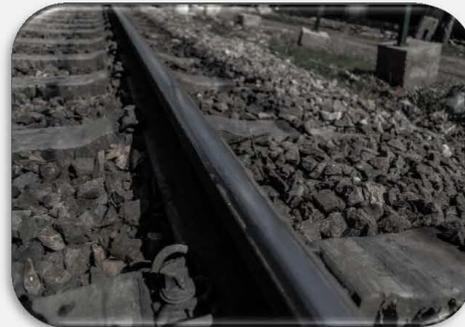
CORRUGATION	
Wavelength	300-1000mm
Amplitude	45 µm
Type of Corrugation	Long Pitch
TRACK PARAMETERS	
Type of Rail	UIC 60 E
Rail Grade	900
Type of Sleepers	B70 Concrete
Type of Fastening System	Skl 14
Type of Rail Pad	RP 700
Curvature (Straight/Curve)	Straight
Lubrication Condition	Unavailable
Date of Renewal/ Reparation	2008

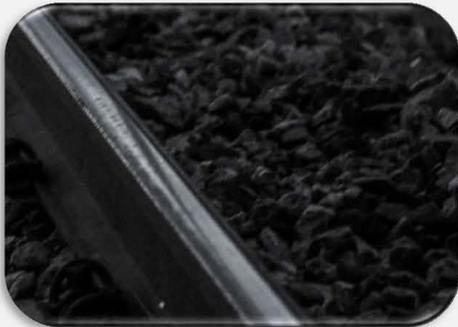
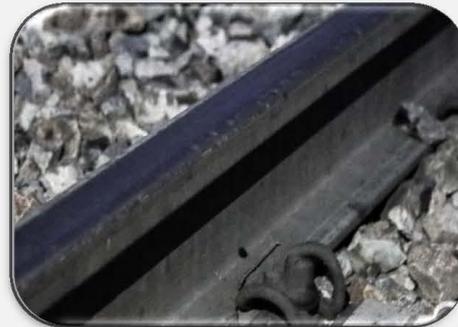
CORRUGATION	
Wavelength	100-300mm
Amplitude	28 µm
Type of Corrugation	Medium Pitch
TRACK PARAMETERS	
Type of Rail	UIC 60 E
Rail Grade	900
Type of Sleepers	B70 Concrete
Type of Fastening System	Skl 14
Type of Rail Pad	RP 700
Curvature (Straight/Curve)	Straight
Lubrication Condition	Unavailable
Date of Renewal/ Reparation	2010

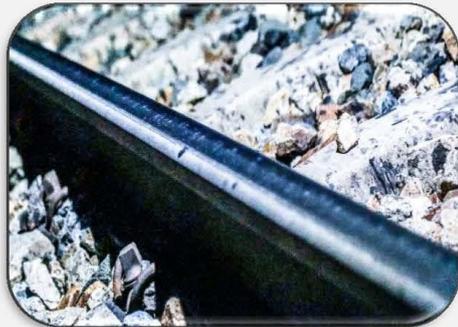
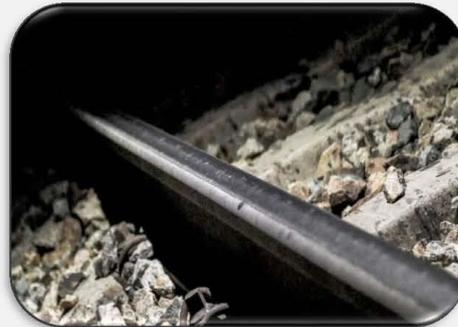
CORRUGATION	
Wavelength	30-100mm
Amplitude	10µm
Type of Corrugation	Short Pitch
TRACK PARAMETERS	
Type of Rail	UIC 60 E
Rail Grade	900
Type of Sleepers	B70 Concrete
Type of Fastening System	Skl 14
Type of Rail Pad	RP 700
Curvature (Straight/Curve)	Straight
Lubrication Condition	Unavailable
Date of Renewal/ Reparation	2012

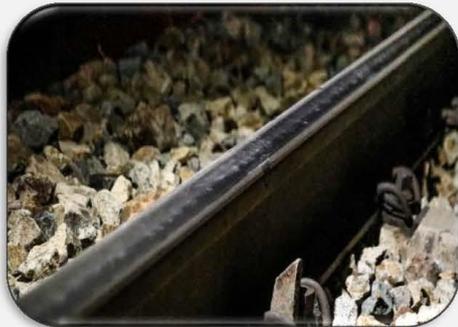
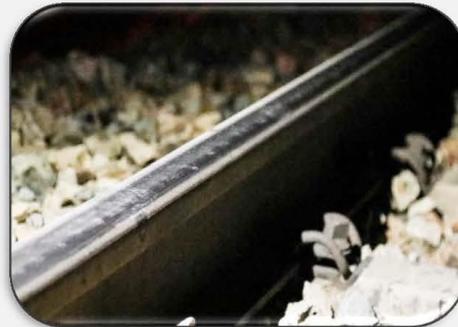
CORRUGATION	
Wavelength	30-100mm
Amplitude	10µm
Type of Corrugation	Short Pitch
TRACK PARAMETERS	
Type of Rail	UIC 60 E
Rail Grade	900
Type of Sleepers	B70 Concrete
Type of Fastening System	Skl 14
Type of Rail Pad	RP 700
Curvature (Straight/Curve)	Straight
Lubrication Condition	Unavailable
Date of Renewal/ Reparation	2013

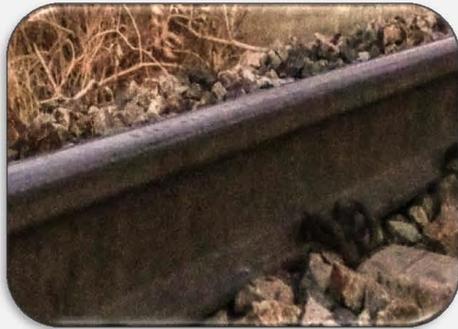
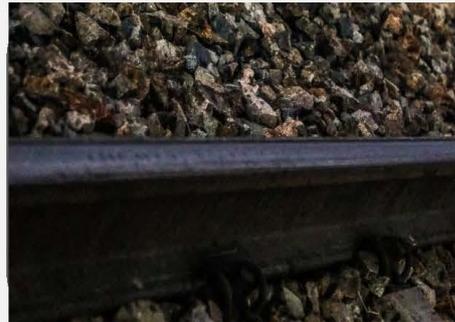
CORRUGATION	
Wavelength	100-300mm
Amplitude	25µm
Type of Corrugation	Medium Pitch
TRACK PARAMETERS	
Type of Rail	UIC 60 E
Rail Grade	900
Type of Sleepers	B70 Concrete
Type of Fastening System	Skl 14
Type of Rail Pad	RP 700
Curvature (Straight/Curve)	Straight
Lubrication Condition	Unavailable
Date of Renewal/ Reparation	2008

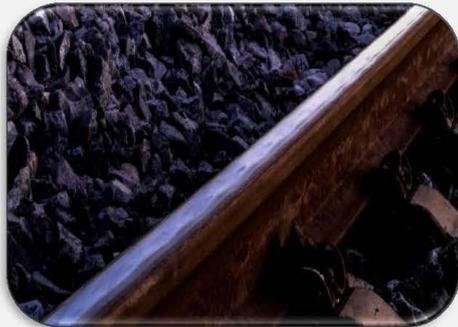
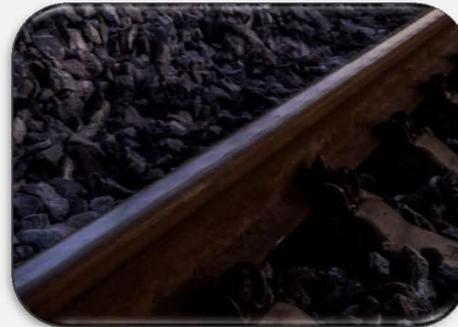
CORRUGATION	
Wavelength	300-1000mm
Amplitude	70µm
Type of Corrugation	Long Pitch
TRACK PARAMETERS	
Type of Rail	UIC 60 E
Rail Grade	900
Type of Sleepers	B70 Concrete
Type of Fastening System	Skl 14
Type of Rail Pad	RP 700
Curvature (Straight/Curve)	Curve
Lubrication Condition	Unavailable
Date of Renewal/ Reparation	2010

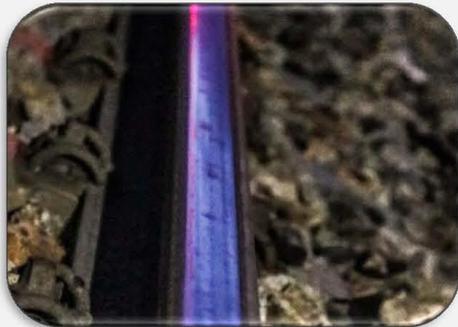
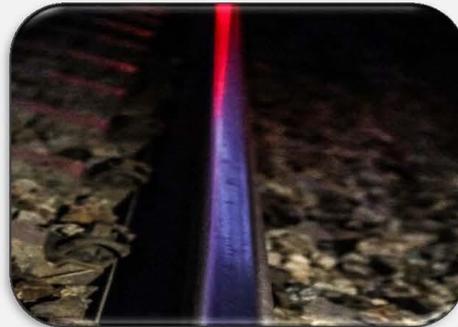
CORRUGATION	
Wavelength	100-300mm
Amplitude	30µm
Type of Corrugation	Medium Pitch
TRACK PARAMETERS	
Type of Rail	UIC 60 E
Rail Grade	900
Type of Sleepers	B70 Concrete
Type of Fastening System	Skl 14
Type of Rail Pad	RP 700
Curvature (Straight/Curve)	Curve
Lubrication Condition	Unavailable
Date of Renewal/ Reparation	2011

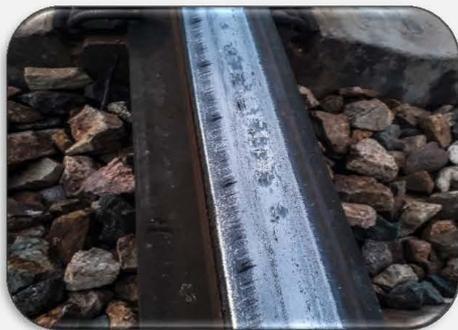
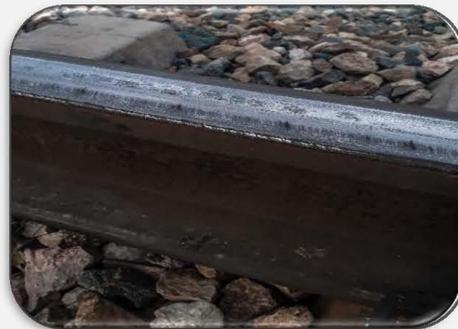
CORRUGATION	
Wavelength	100-300mm
Amplitude	35µm
Type of Corrugation	Medium Pitch
TRACK PARAMETERS	
Type of Rail	UIC 60 E
Rail Grade	900
Type of Sleepers	B70 Concrete
Type of Fastening System	Skl 14
Type of Rail Pad	RP 700
Curvature (Straight/Curve)	Straight
Lubrication Condition	Unavaible
Date of Renewal/ Reparation	2012

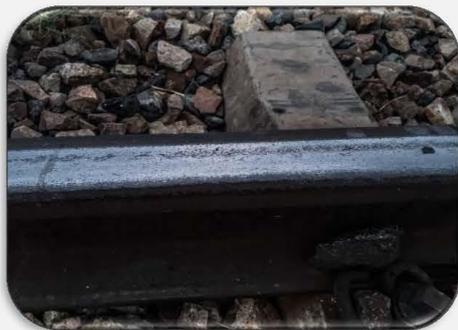
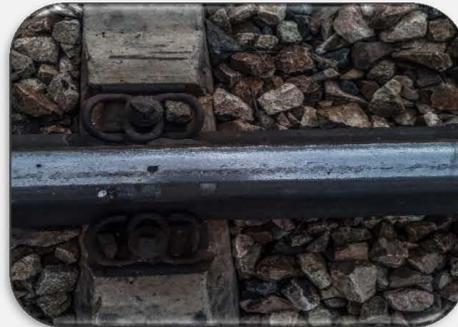
CORRUGATION	
Wavelength	30-100mm
Amplitude	10µm
Type of Corrugation	Short Pitch
TRACK PARAMETERS	
Type of Rail	UIC 60 E
Rail Grade	900
Type of Sleepers	B70 Concrete
Type of Fastening System	Skl 14
Type of Rail Pad	RP 700
Curvature (Straight/Curve)	Straight
Lubrication Condition	Unavailable
Date of Renewal/ Reparation	2011
