Needs Tailored Interoperable Railway Infrastructure

# Dynamic measurements in Slovenia

NeTIRail-INFRA final conference, Ljubljana – 24th May 2018

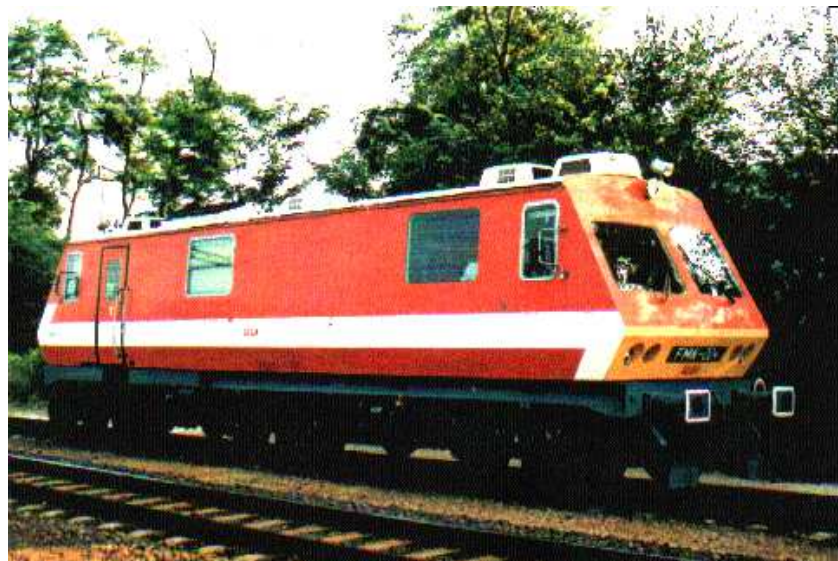
- measurements with traditional high resolution track monitoring equipment integrated into the train (measuring trains)
- monitoring technologies, performed with portable measuring equipment on standard vehicles

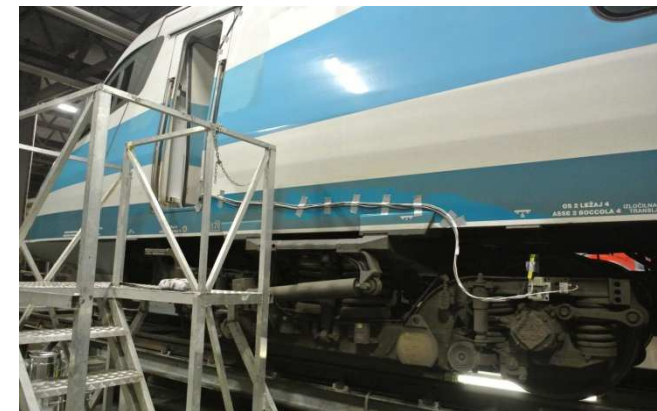
- Portable measuring equipment, sensors mounted on a bogie of passenger train, measuring system
- Preliminary preparation, calibration, installation, setup file
- Measuring lateral and vertical acceleration
- Average lateral and vertical acceleration, lateral force
- GPS kilometre position of a train

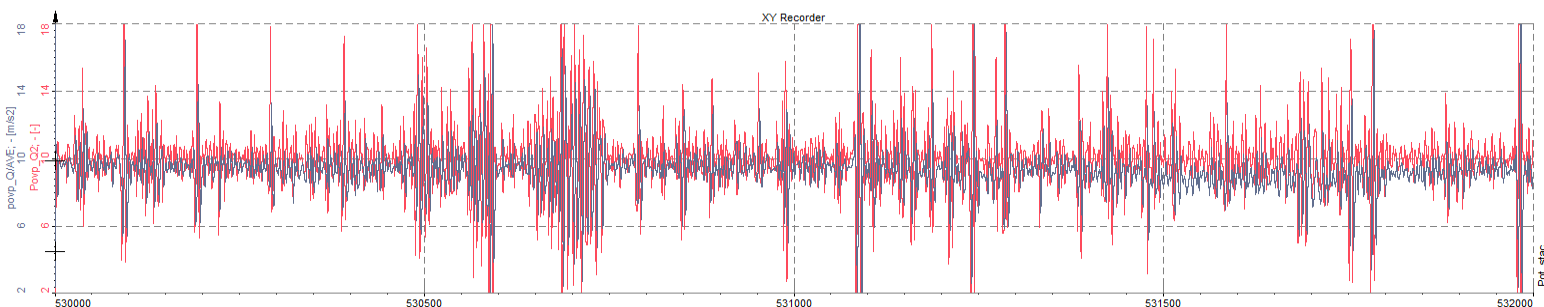
- Low frequency accelerometers: four vertical and four lateral accelerometers; Dewesoft, frequency range 80 Hz, sensitivity 30 and 145 mV/g.
- High frequency accelerometers: four vertical and four lateral accelerometers; Dytran DC response accelerometer,  $\pm 100g$  range, frequency response 0 - 2500 Hz, sensitivity 40 mV/g.

→ difference in detection of vibration frequencies

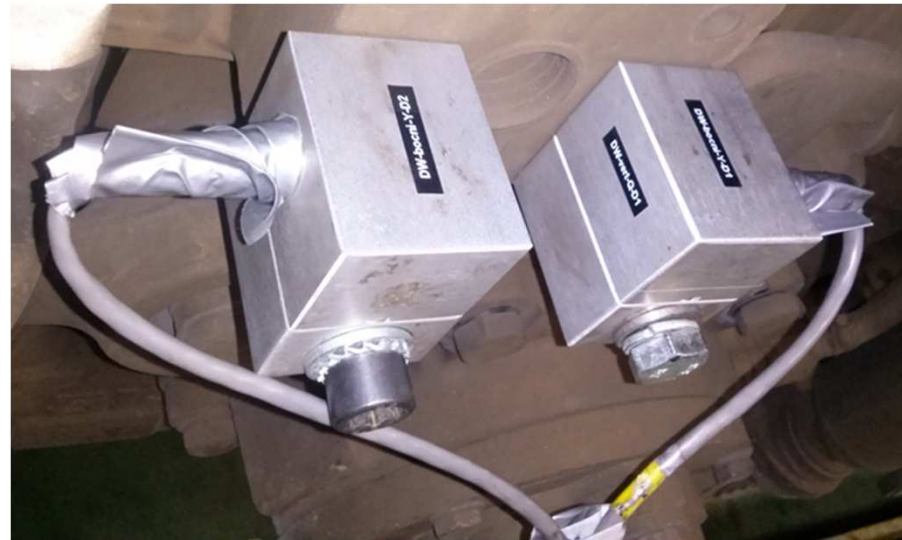
- Low frequency  
accelerometers  
Dewesoft

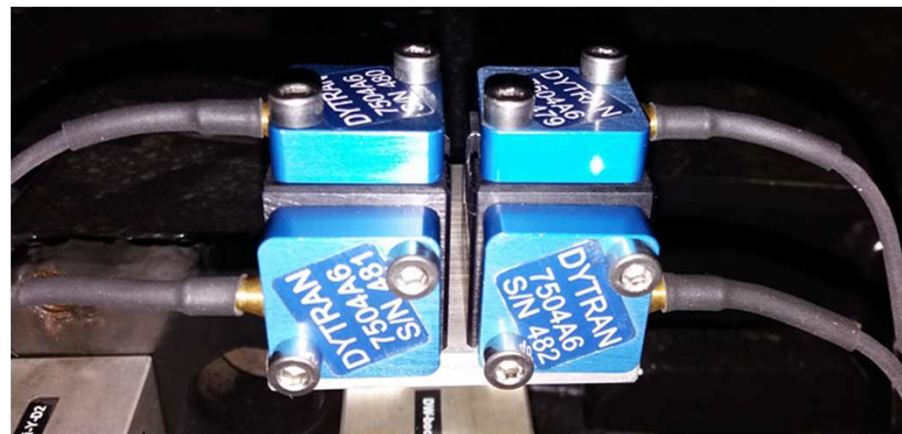
- High frequency  
accelerometers  
Dytran

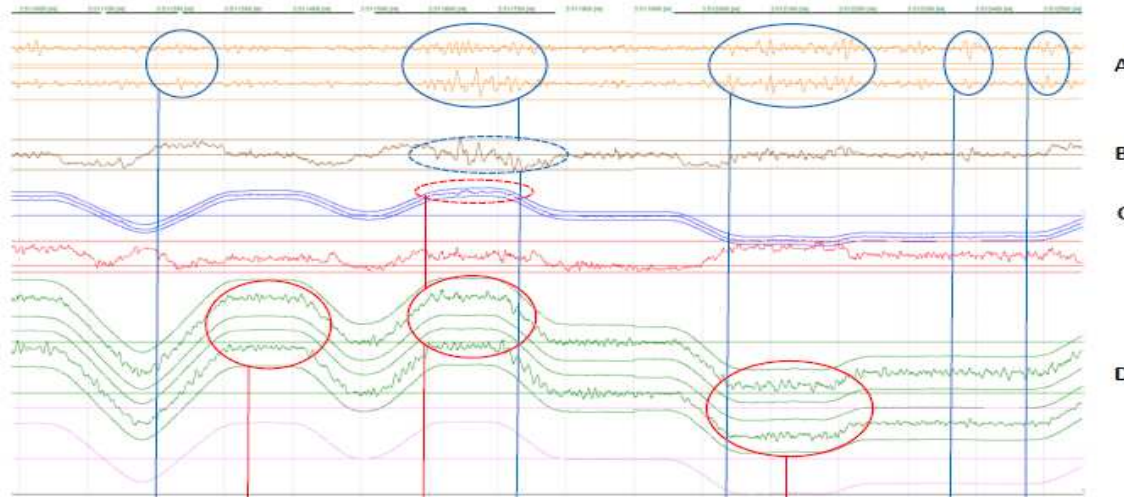
Figure 4-4 Parameters of geometric measurements on 1,5 km section 10L 511.000-512.500 (DrezStac), November 2017.

A – Stability (left and right rail)

B – Twist

C – Cant

D – Direction (left and right rail)

- correlation of lateral acceleration (F) with geometric parameters (D, C)
- Lateral acceleration : Direction, Cant
- correlation of vertical acceleration (E) and geometric parameters (A, B)
- Vertical acceleration : Stability, Twist

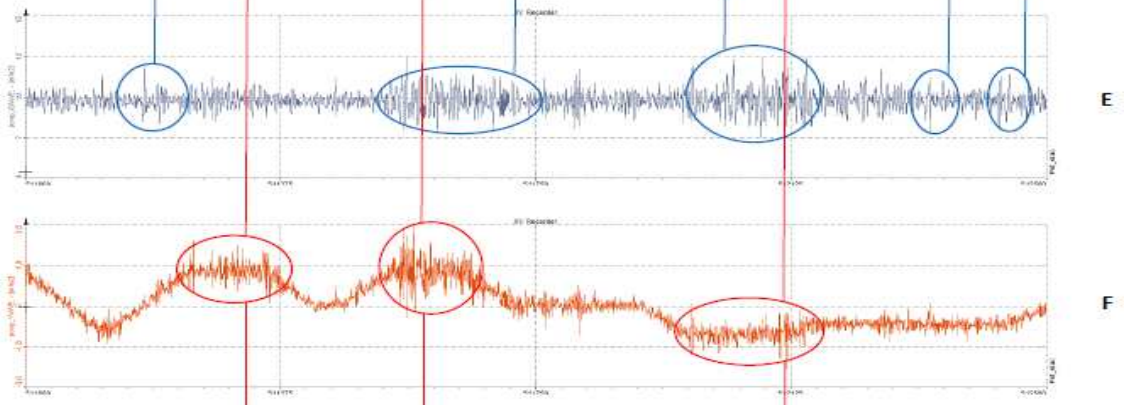
Figure 4-5 Vertical and lateral acceleration on 1,5 km section 10L 511.000-512.500 (DEWESoft), December 2017.

E – Vertical acceleration

F – Lateral acceleration

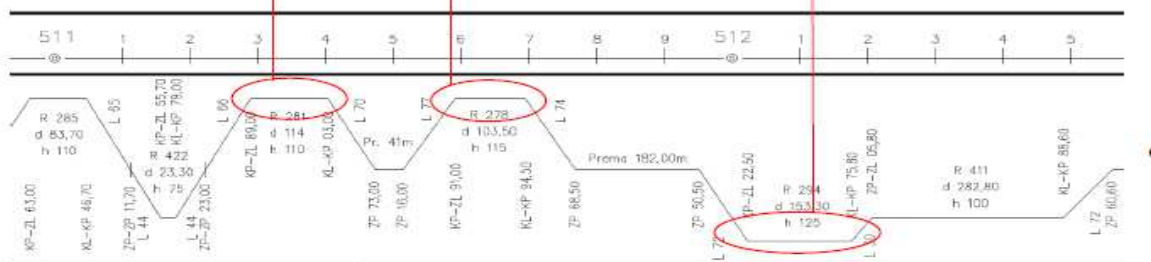
Figure 4-6 Longitudinal profile of 1,5 km section 10L 511.000-512.500.

G – Longitudinal profile

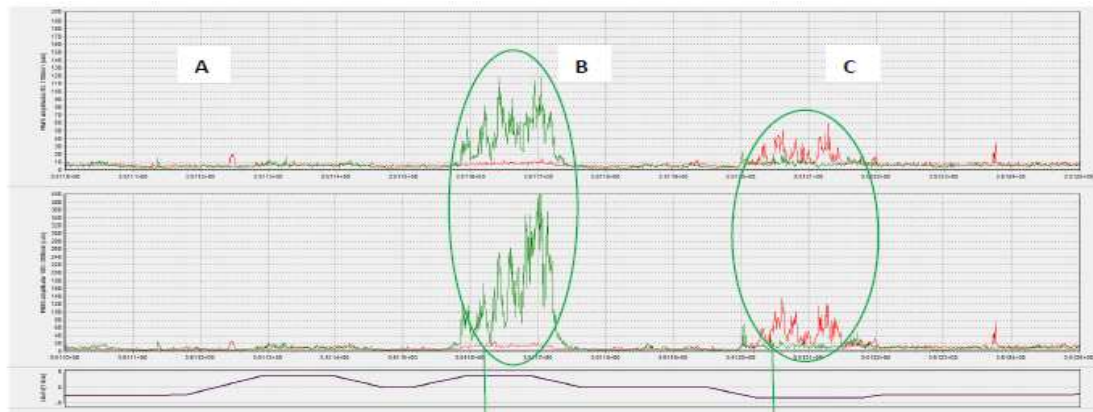
Figure 4-7 Corrugation measurements on 1,5 km section 10L 511.000-512.500 (CorrViewer), red-left rail, green-right rail; August-September 2016.

A – No corrugation

B – Corrugation of right rail

C – Corrugation of left rail

- correlation of vertical acceleration and track stability
- **Vertical acceleration : Stability**
- track sections with corrugation, on right or left rail
- **Corrugation : Greater difference in signal density (strength) of vertical acceleration - *between high and low-frequency sensors???***

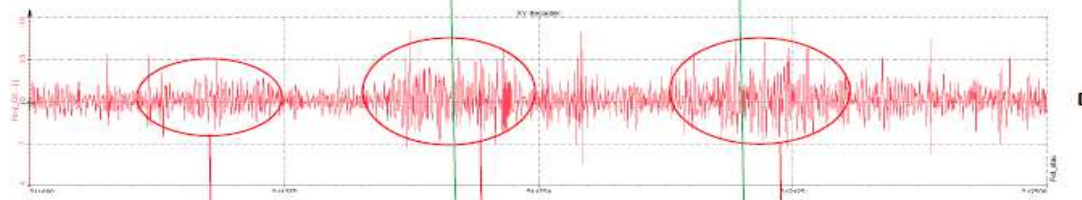
Figure 4-8 Vertical acceleration on 1,5 km section 10L 511.000-512.500 (DEWESoft); December 2017.

D – Vertical acceleration

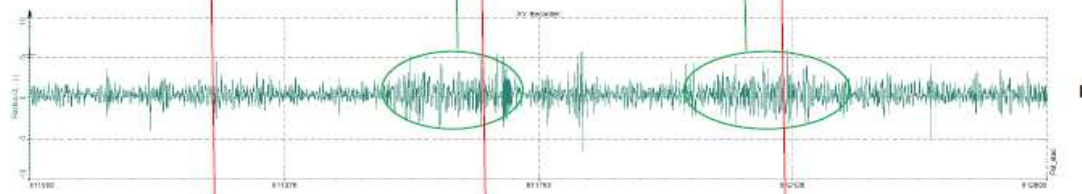
Figure 4-9 Difference in vertical acceleration between high-frequency and low-frequency sensors.

E – Difference between high and low-frequency vertical acceleration

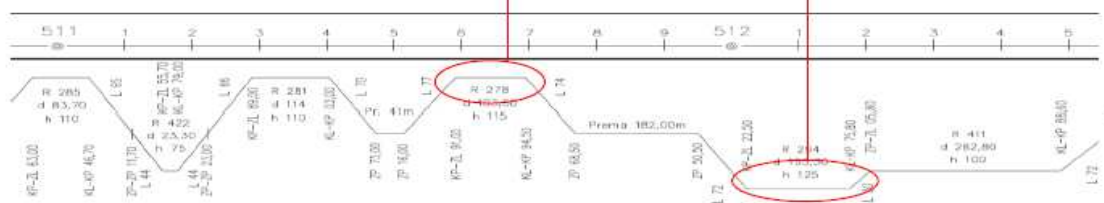
Figure 4-11 Longitudinal profile of 1,5 km section 10L 511.000-512.500.

G – Longitudinal profile

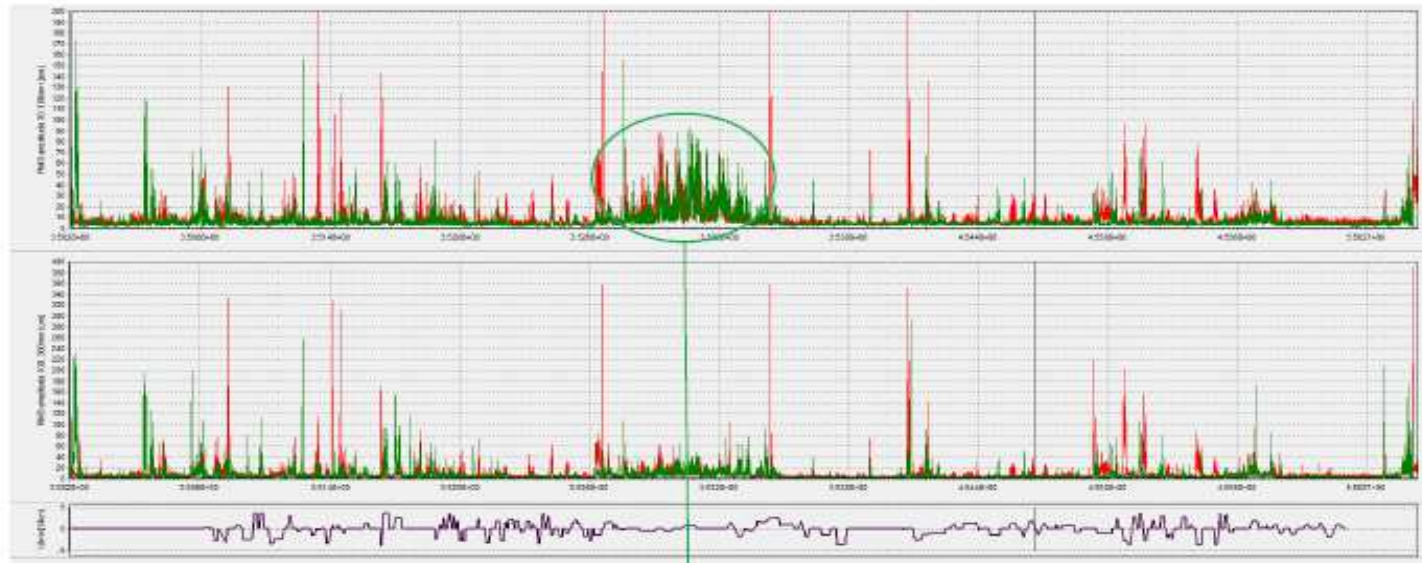
Figure 4-12 Corrugation on rail line 10L state border-Dobova-Ljubljana.

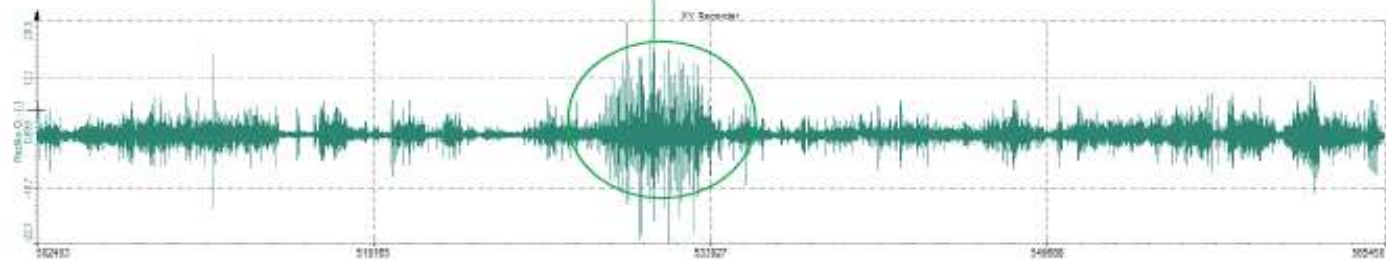
Figure 4-13 Difference in vertical acceleration between high-frequency and low-frequency sensors on rail line 10L state border-Dobova-Ljubljana.

- great reliability on the correlation between dynamic and geometric parameters
- correlation for corrugation with a dynamic vertical parameter, but not so pronounced → sensors should be placed closer to the formation of the corrugation
- **Potencial usability for "early diagnostics"** purposes  
→ *to improve system, additional research, other different sensors tested*
