Needs Tailored Interoperable Railway Infrastructure

Dynamic measurements in Slovenia

NeTIRail-INFRA final conference, Ljubljana – 24th May 2018

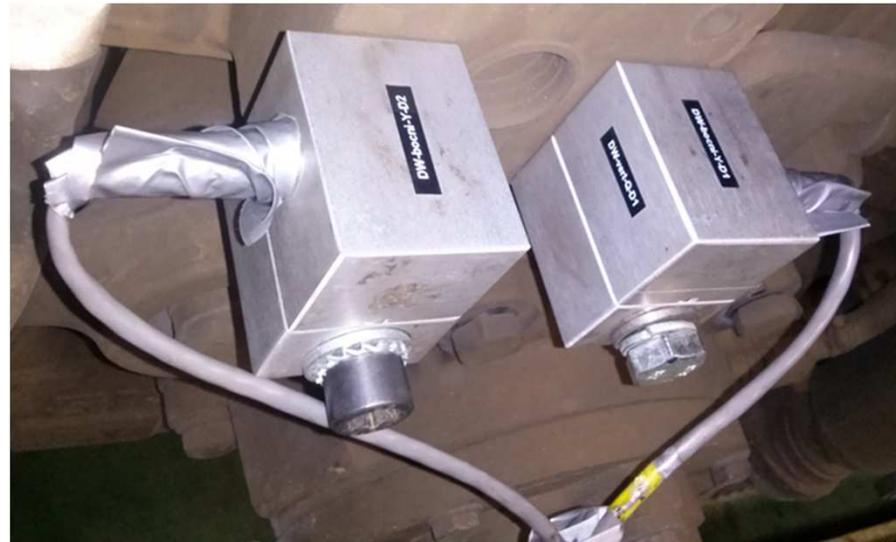
- Low frequency
accelerometers
Dewesoft

- Low frequency accelerometers: four vertical and four lateral accelerometers; Dewesoft, frequency range 80 Hz, sensitivity 30 and 145 mV/g
- High frequency accelerometers: four vertical and four lateral accelerometers; Dytran DC response accelerometer, $\pm 100g$ range, frequency response 0 - 2500 Hz, sensitivity 40 mV/g

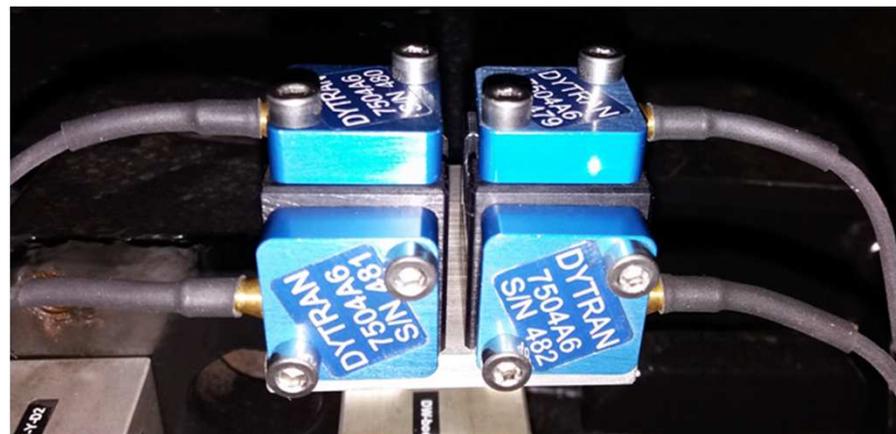
- High frequency
accelerometers
Dytran

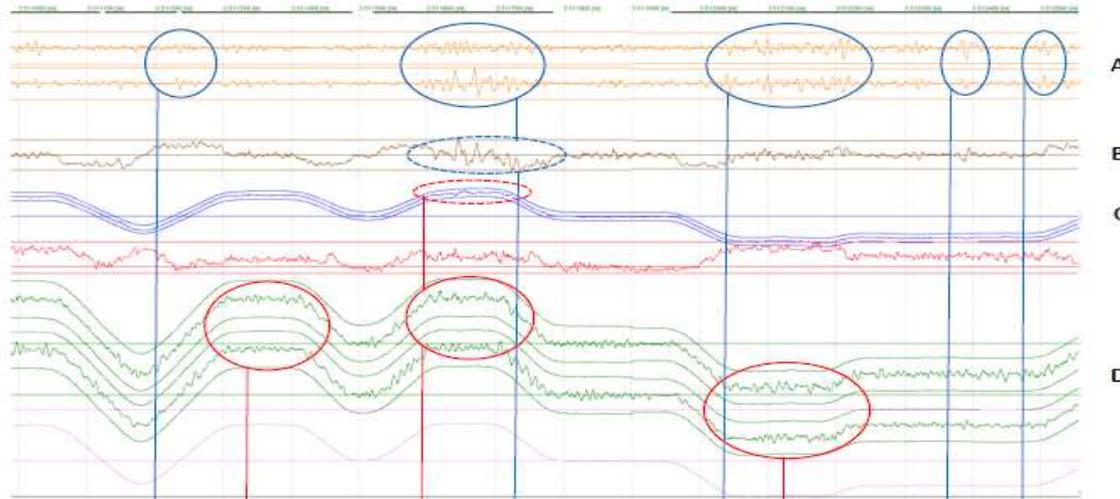
Figure 4-4 Parameters of geometric measurements on 1,5 km section 10L 511.000-512.500 (DrezStac), November 2017.

A – Stability (left and right rail)

B – Twist

C – Cant

D – Direction (left and right rail)

- correlation of lateral acceleration (F) with geometric parameters (D, C)
- **Lateral acceleration : Direction, Cant**
- correlation of vertical acceleration (E) and geometric parameters (A, B)
- **Vertical acceleration : Stability, Twist**

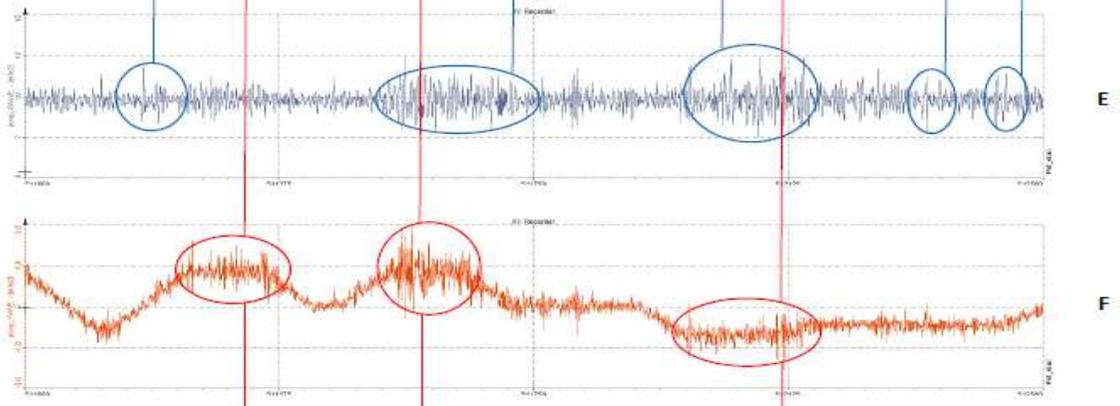
Figure 4-5 Vertical and lateral acceleration on 1,5 km section 10L 511.000-512.500 (DEWESoft), December 2017.

E – Vertical acceleration

F – Lateral acceleration

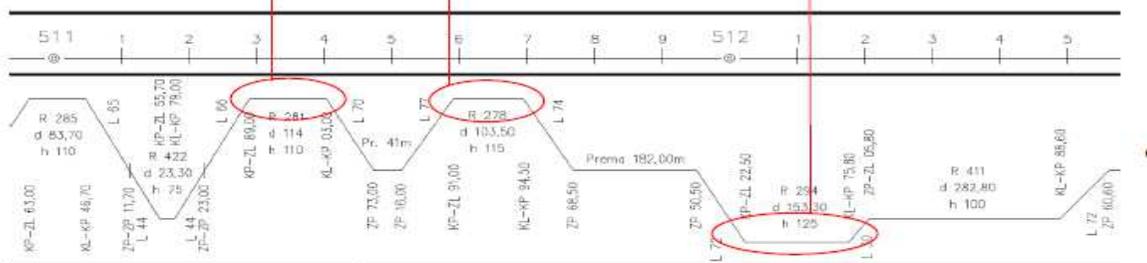
Figure 4-6 Longitudinal profile of 1,5 km section 10L 511.000-512.500.

G – Longitudinal profile

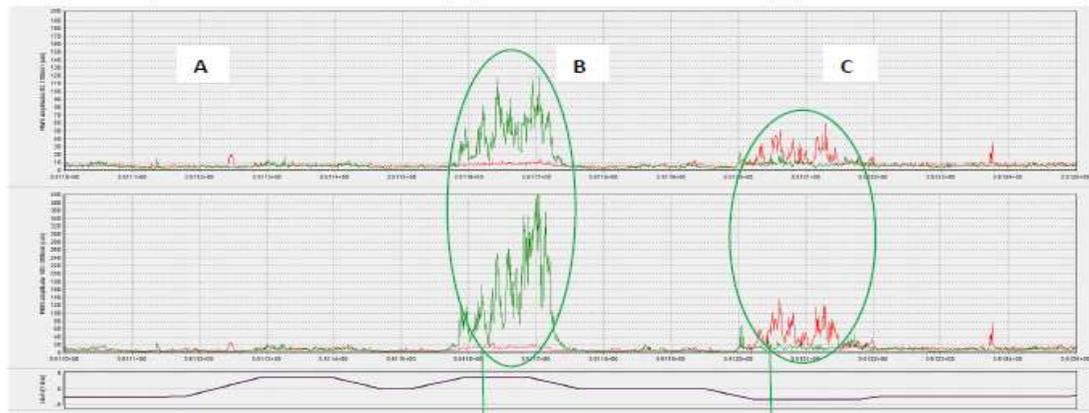
Figure 4-7 Corrugation measurements on 1,5 km section 10L 511.000-512.500 (CorrViewer), red-left rail, green-right rail; August-September 2016.

A – No corrugation

B – Corrugation of right rail

C – Corrugation of left rail

- correlation of vertical acceleration and track stability
- **Vertical acceleration : Stability**
- track sections with corrugation, on right or left rail
- **Corrugation : Greater difference in vertical acceleration signal - *between high and low-frequency sensors???***

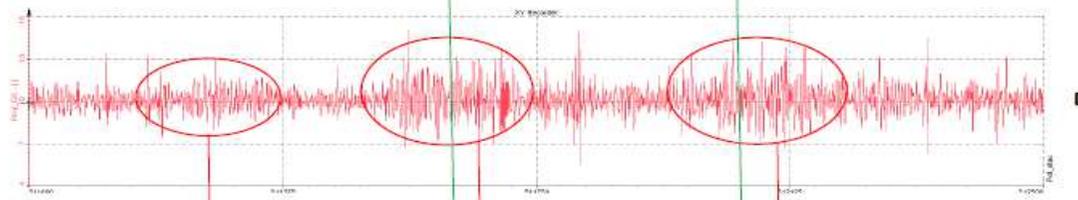
Figure 4-8 Vertical acceleration on 1,5 km section 10L 511.000-512.500 (DEWESoft); December 2017.

D – Vertical acceleration

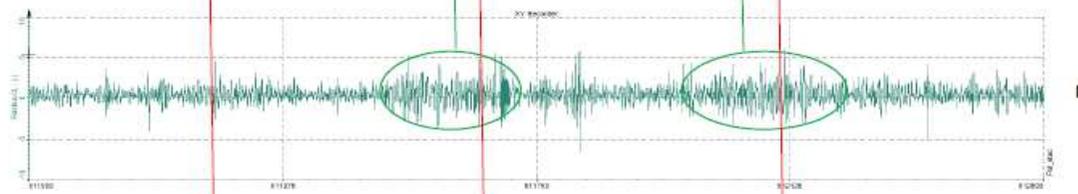
Figure 4-9 Difference in vertical acceleration between high-frequency and low-frequency sensors.

E – Difference between high and low-frequency vertical acceleration

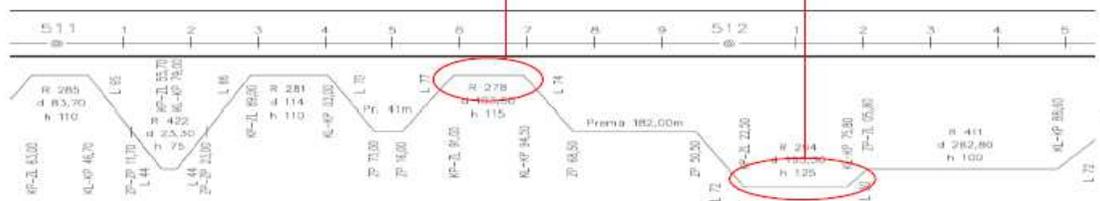
Figure 4-11 Longitudinal profile of 1,5 km section 10L 511.000-512.500.

G – Longitudinal profile

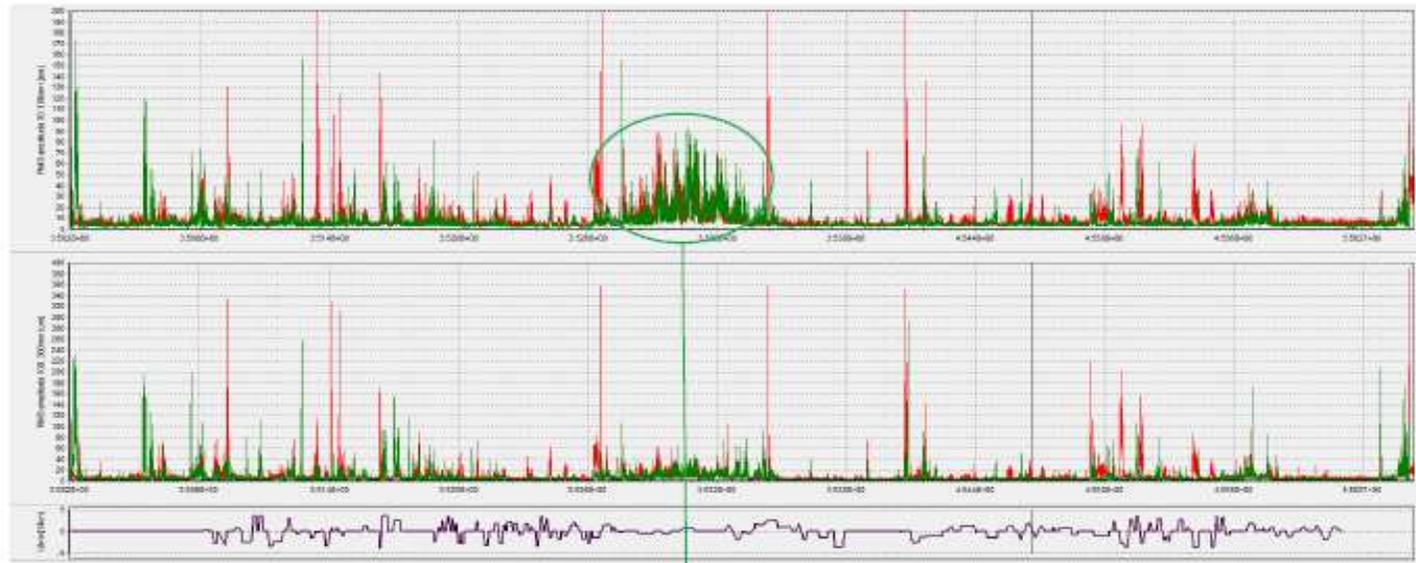
Figure 4-12 Corrugation on rail line 10L state border-Dobova-Ljubljana.

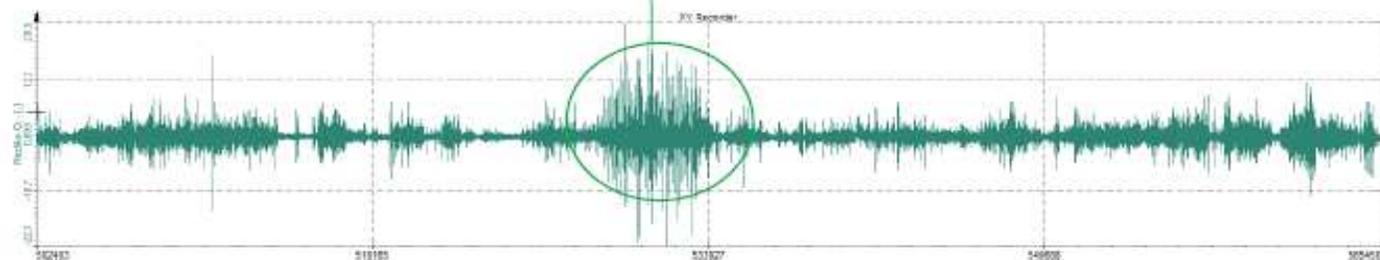
Figure 4-13 Difference in vertical acceleration between high-frequency and low-frequency sensors on rail line 10L state border-Dobova-Ljubljana.

- great reliability on the correlation between dynamic and geometric parameters
- correlation for corrugation with a dynamic vertical parameter, but not so pronounced → sensors should be placed closer to the formation of the corrugation
- **Potential usability of dynamic measuring equipment for "early diagnostics" purposes**
→ *to improve system, additional research, other different sensors tested*
